**DRINKING WATER QUALITY REGULATOR
FOR SCOTLAND**

Drinking Water Quality in Scotland 2017 Public Water Supply

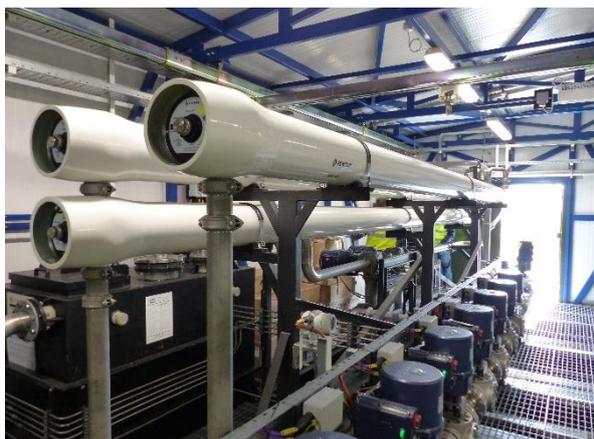
RO membrane at Whalsay WTW

pH of the supply, along with the re-solubilisation of aluminium deposits in the water main, which will have accumulated over the life of the old treatment works. This created a high concentration of aluminium in the water supplied to consumers, and the aggressive nature of the water also put consumers at risk of high concentrations of plumbing metals, including lead.

At its peak, a sample taken in the northern extremity of the system showed an aluminium level of 1368µg/l. The standard for aluminium in Regulations is 200µg/l. Over the course of

the incident, several operational actions were taken to try to resolve the issues at the works, but ultimately the reverse osmosis stage was isolated, allowing recovery to take place. Restrictions on use were put in place for 120 properties for two days and the remaining 20 properties for a further day. Once a new carbon dioxide dosing system was installed at the works, a balanced, less aggressive treated water was achieved and the water supply complied with regulatory standards.

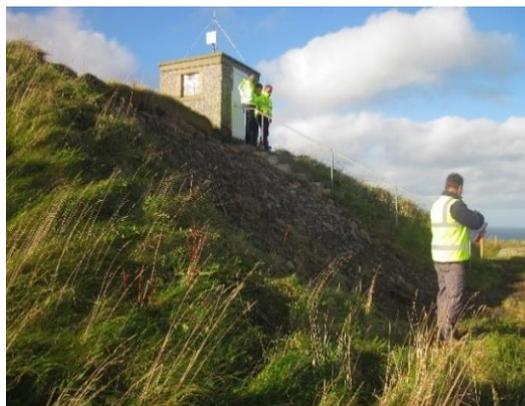
DWQR audit of Shapinsay SR

A sample taken from Shapinsay SR, Orkney, in September 2017 failed microbiological standards with three coliforms and one *E. coli* present. On receipt of the laboratory report, additional samples were taken from the service reservoir the following day. However, following discussions with the Consultant in Public Health Medicine (CPHM), a decision was taken to issue a “Do Not Drink, Do Not Cook” notice and bottled water was shipped to Shapinsay for distribution to all consumers. An Incident Management Team was formed to co-ordinate and agree actions and roles during the incident. As a precaution, a decision was also taken to isolate the service reservoir from the water network to supply directly from the mainland and restrictions on water use notices were delivered to consumers. All five additional samples taken following the initial failure met microbiological standards and it was agreed to lift the restriction on use. “End of restriction” notices were provided to all consumers. The service reservoir was refilled and put back into supply the following day, following confirmation that the samples that were taken prior to the service reservoir being isolated were clear.

Scottish Water’s investigation has failed to identify conclusively the root cause of the sample failure but has identified two issues: the handling and storage of sample bottles and the possibility of sample contamination; and the integrity of the service reservoir itself.

Its investigation of the service reservoir identified a number of concerns with the tank structure that may cause contamination of the supply. Reference to rainfall records highlights heavy rain in the locality in the days prior to the sample being taken. DWQR staff visited the site following the incident, carrying out an audit of the service reservoir and made a number of observations on integrity issues which were of sufficient concern to expect priority attention by Scottish Water.
