SECTION 5

RISK ASSESSMENT CASE STUDIES

These cases studies illustrate the **practicalities of carrying out risk assessments** on private water supplies. They focus on the **site survey** and **supply survey** questions, providing many useful photographs as well as the diagram required for each study.

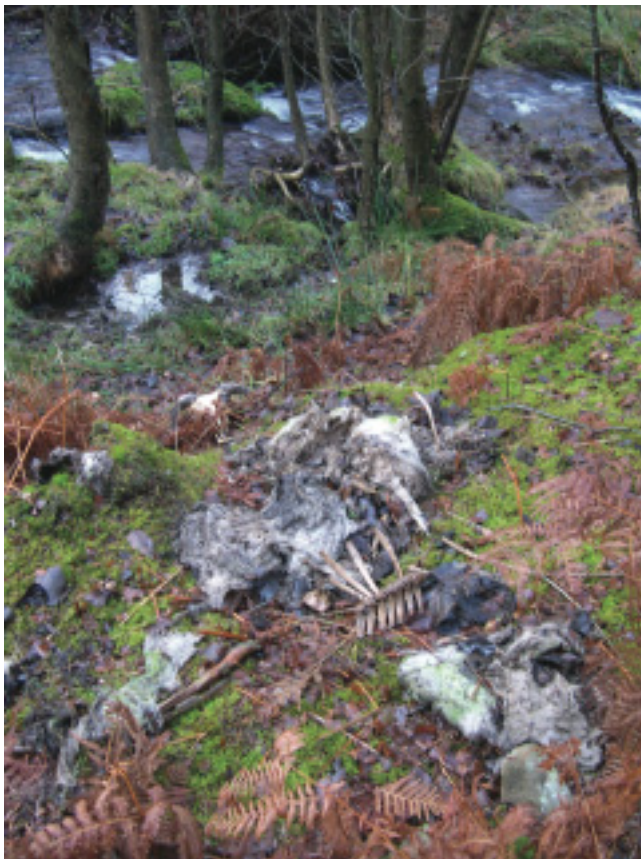
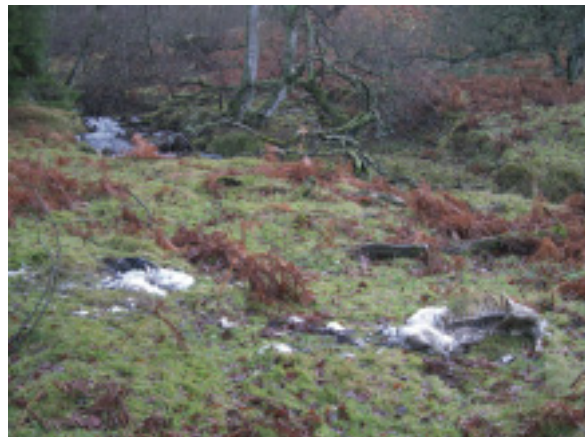
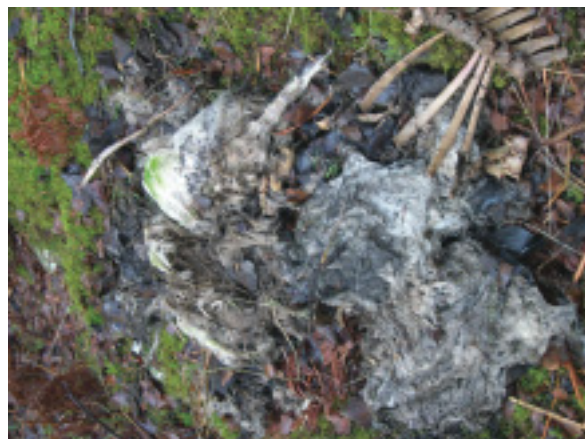
Question 23 was scored Yes – risk characterisation high - as there was evidence of sheep grazing around the burn in the reaches above the Garden boundary. Indeed several dead sheep have had to be removed from the catchment in previous years – some quite close to the burn itself. Figure 5.2 illustrates the animal remains found near the Scrape Burn. The hazard assessment likelihood was scored as permanent (16) giving an overall score of 256.

Figure 5.2 Animal remains beside Scrape Burn

Overall these scores result in the source risk being assessed as High with recommended interventions focusing on trying to reduce access of animals to the burn, controlling forestry activity in the catchment, protecting drain and scour pipes from entry by vermin, identifying pipe materials and being aware that heavy rainfall can have detrimental effects on the water quality.

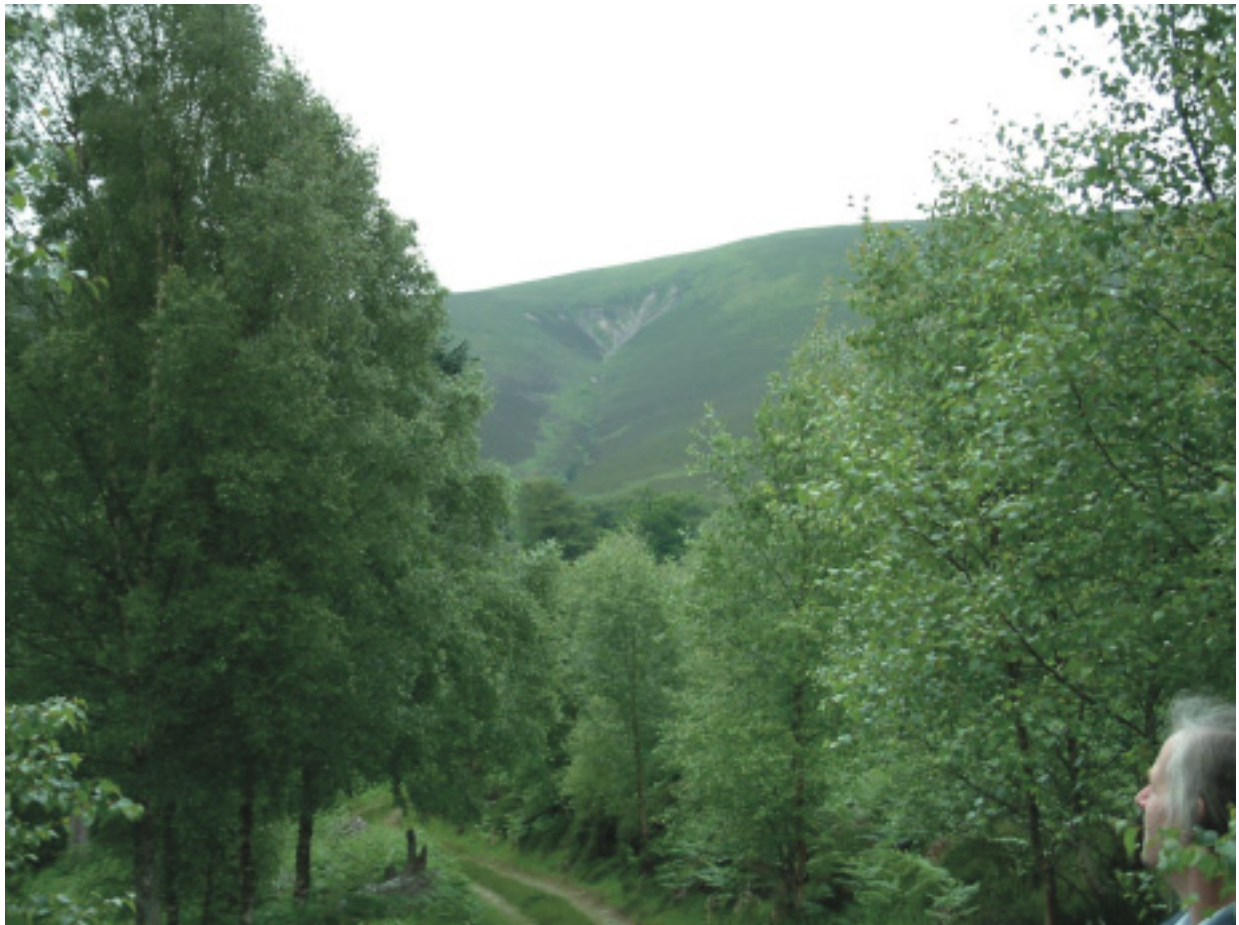
Figure 5.3 Scrape Burn catchment showing erosion on heather moor at head of catchment

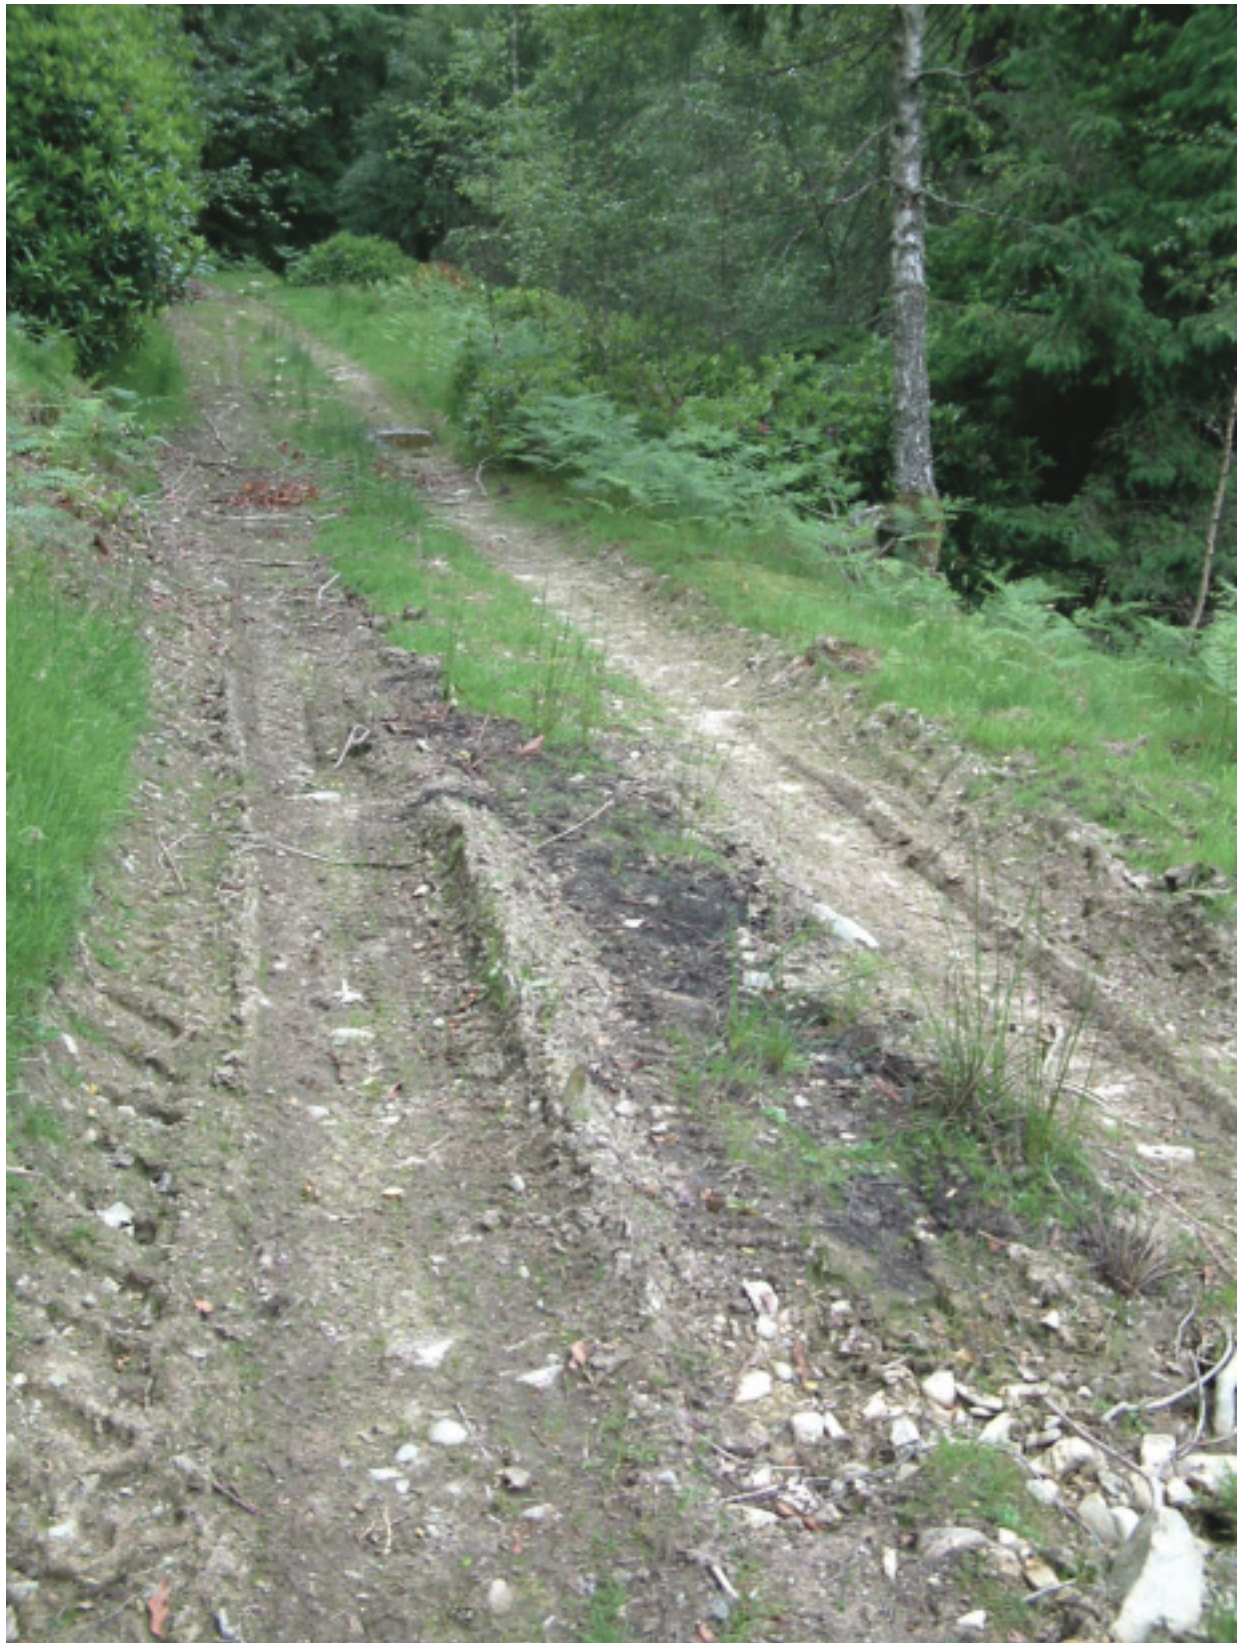
Question 30 was scored as yes – risk characterisation medium – as the catchment area includes large areas of commercial forestry as well as the forestry activity associated with the maintenance of the Garden. The hazard assessment likelihood was scored as permanent (16) as the activity occurs intermittently throughout the year and may not be notified to the Garden when the work is being undertaken in areas outwith the Garden.

Figure 5.4 Sump oil on trackway

Scrape Burn is down slope on right hand side of the picture.

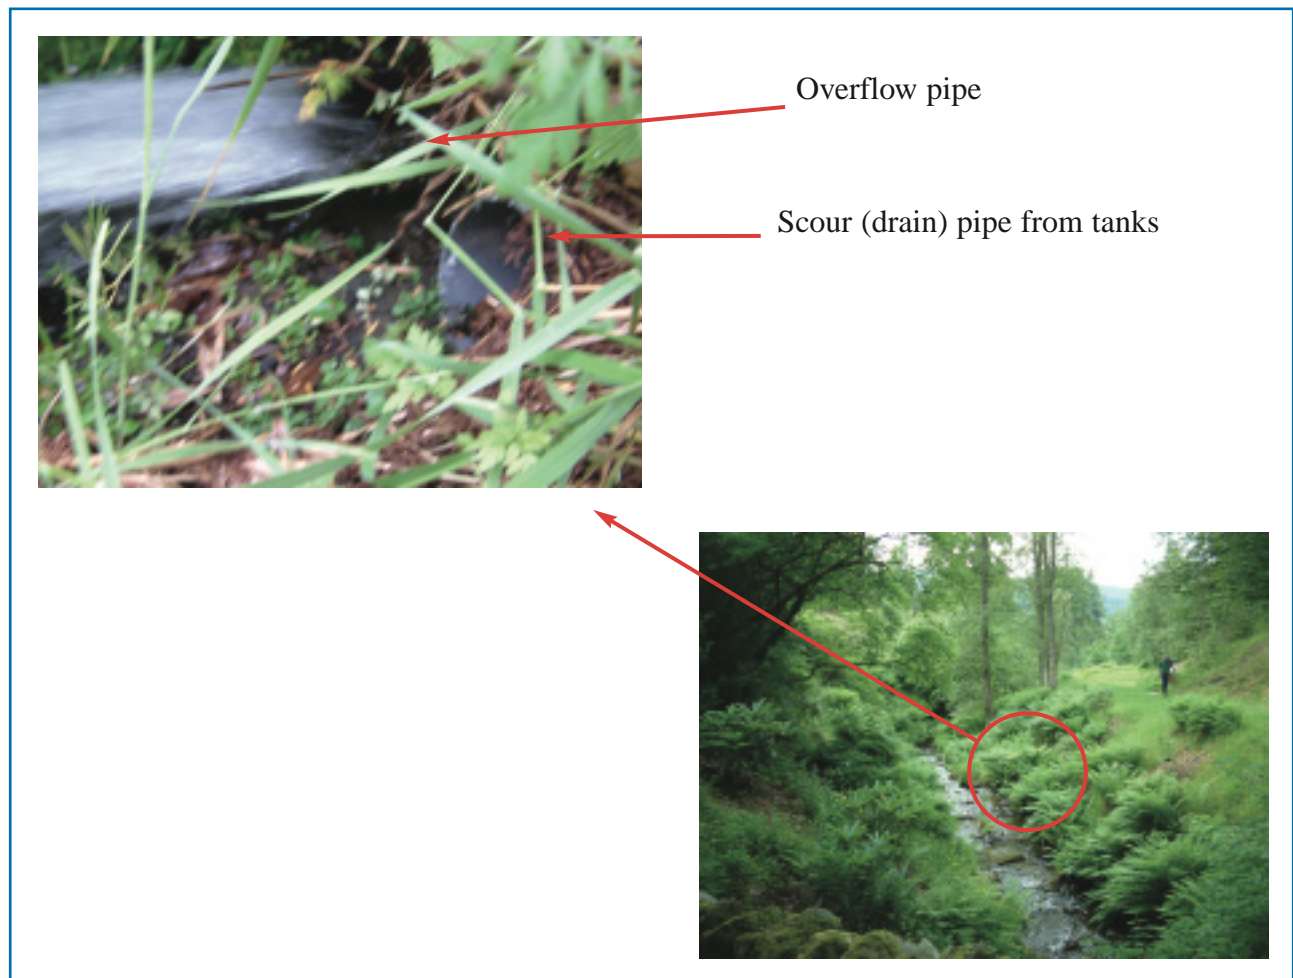
Question 41 was scored as yes – risk characterisation High – as the drain and scour lines did not have vermin protection at their outlets. The hazard assessment likelihood was scored as permanent (16) giving an overall score of 128.

Figure 5.5 Drain and scour pipe details from collection tanks showing vermin protection absent

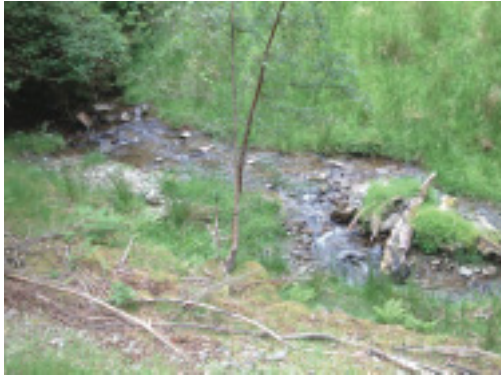
Question 48 was scored as Yes - risk characterisation High – the garden staff noted that the burn experiences significant changes in the level and flow throughout the year depending on the prevailing weather conditions. The hazard assessment likelihood was considered as once per year (scoring 2).

Figure 5.6 Scrape Burn showing evidence of historical spate flow conditions

Scrape Burn showing wind fallen logs carried by the burn when in spate

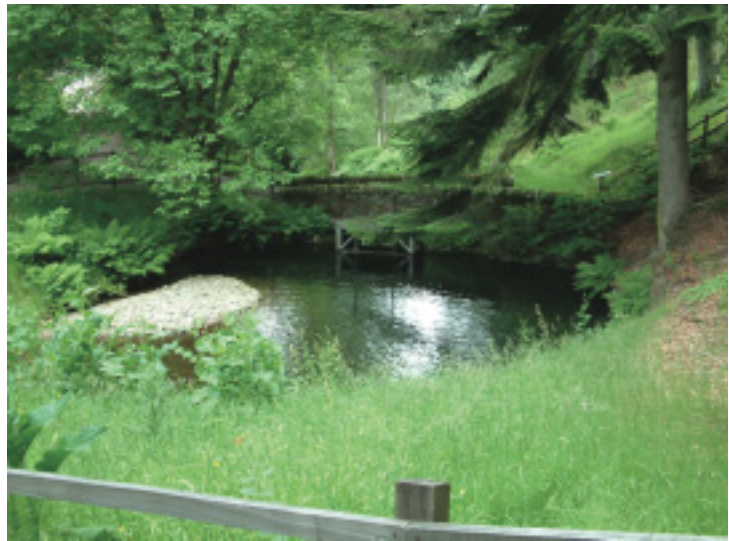
Pond formed from Scrape Burn used as source of drinking water supply at Dawyck Garden

(Note gravel deposits washed into the pond during spate flows)

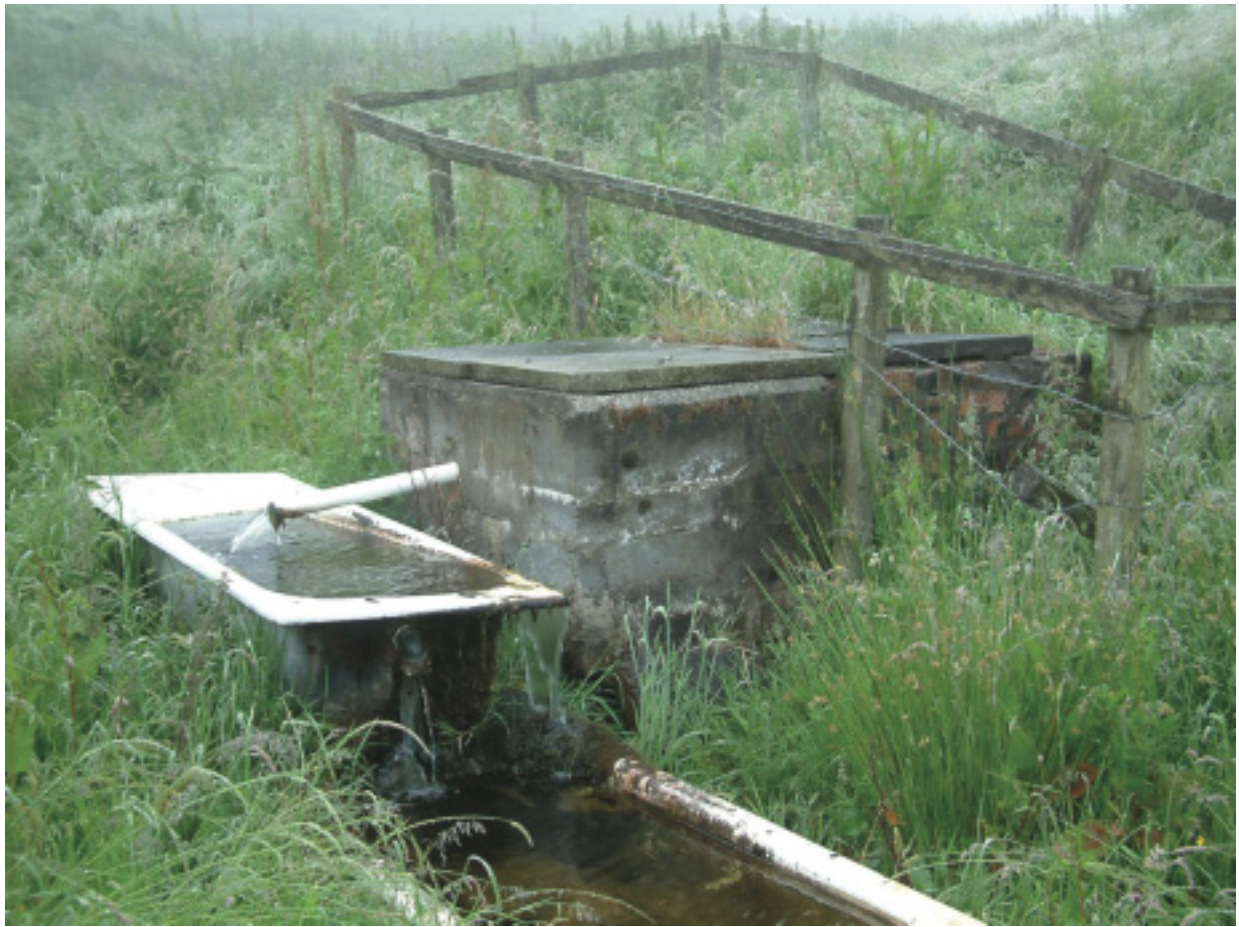
The source collection chamber was located in an area of boggy ground. Due to the waterlogged nature of the ground and the construction of the source it was unlikely that this was a spring supply. Springs may well be feeding the boggy ground but the source had not tapped directly into the source of the spring and so any water collected was under the influence of the surface/soil water. For this reason the source was assessed as a surface water source. The boggy conditions were almost certainly a permanent feature in all but the driest of conditions.

Figure 5.8 General situation encountered at source A1 (Weathertop)

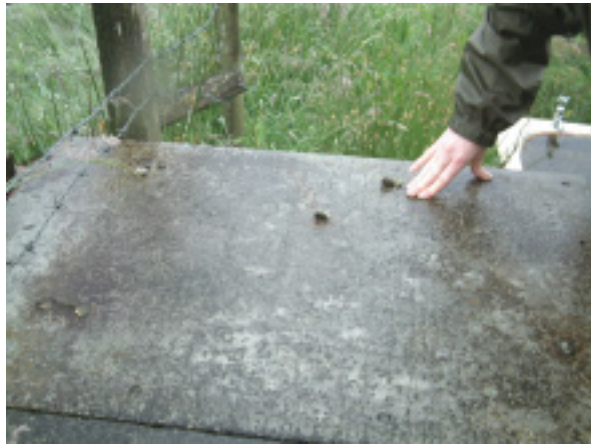
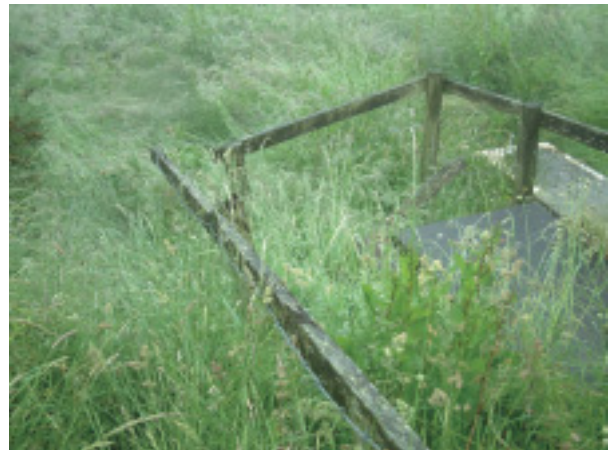
Question 23 was scored as Yes – risk characterisation High – as there was evidence of the surrounding catchment being used for livestock production on a year-round basis. The hazard assessment likelihood score was 16 giving an overall score of 256.

Figure 5.9 Evidence of faecal material deposited on top of collection tank at site A1

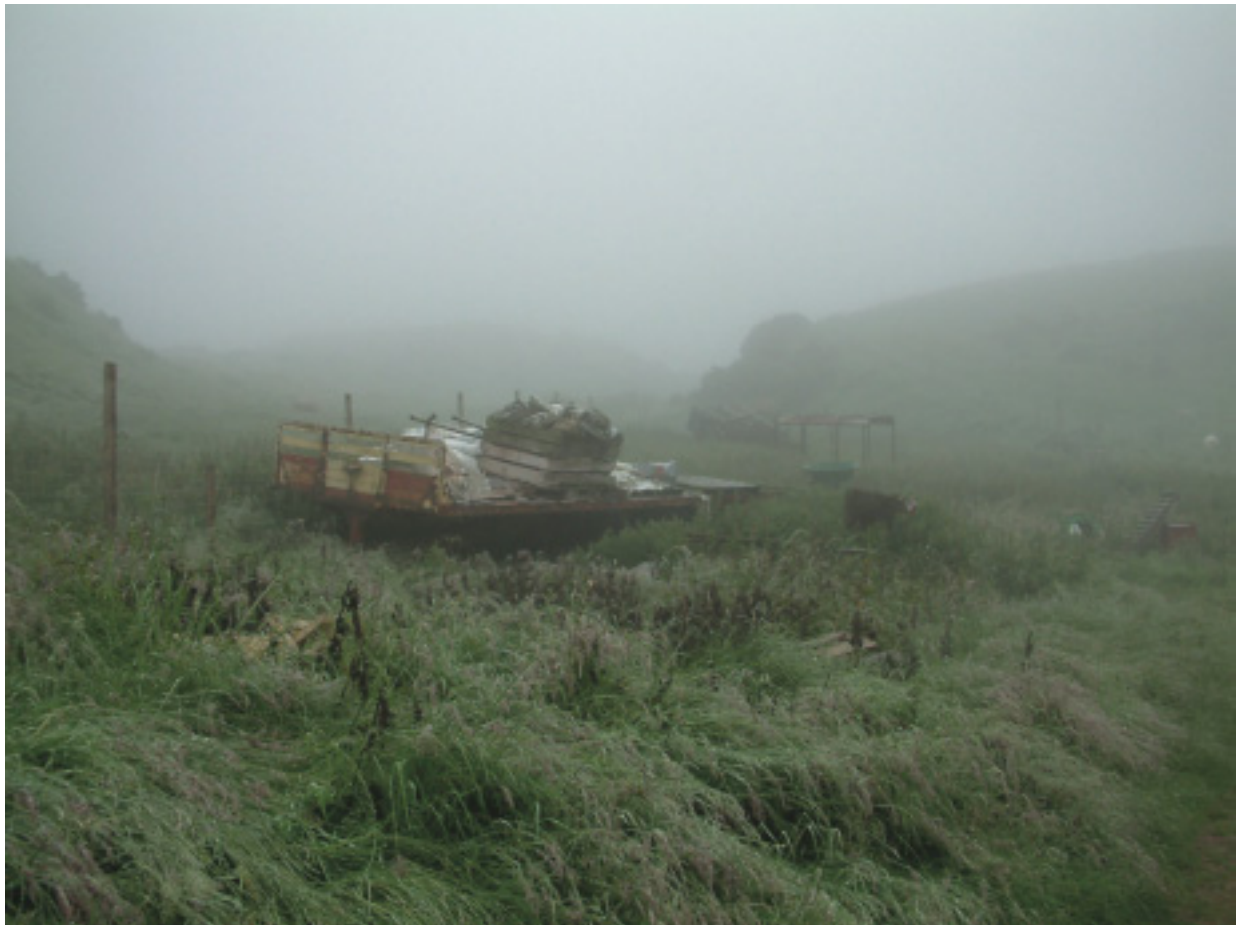
Question 25 was scored as Yes – risk characterisation High – as the source collection structure was down-slope of an area where agri-chemicals and other materials were being stored. The materials appeared to have been present for a long period of time and so the hazard assessment likelihood score was 16 giving an overall score of 128.

Question 32 was scored as Yes – risk characterisation High – for the reasons given in response to question 25. Again the hazard assessment likelihood score was 16 giving an overall score of 128.

Figure 5.10 Agri-chemical storage upslope of collection system and boggy ground. Waste disposal/waste storage area is behind this area

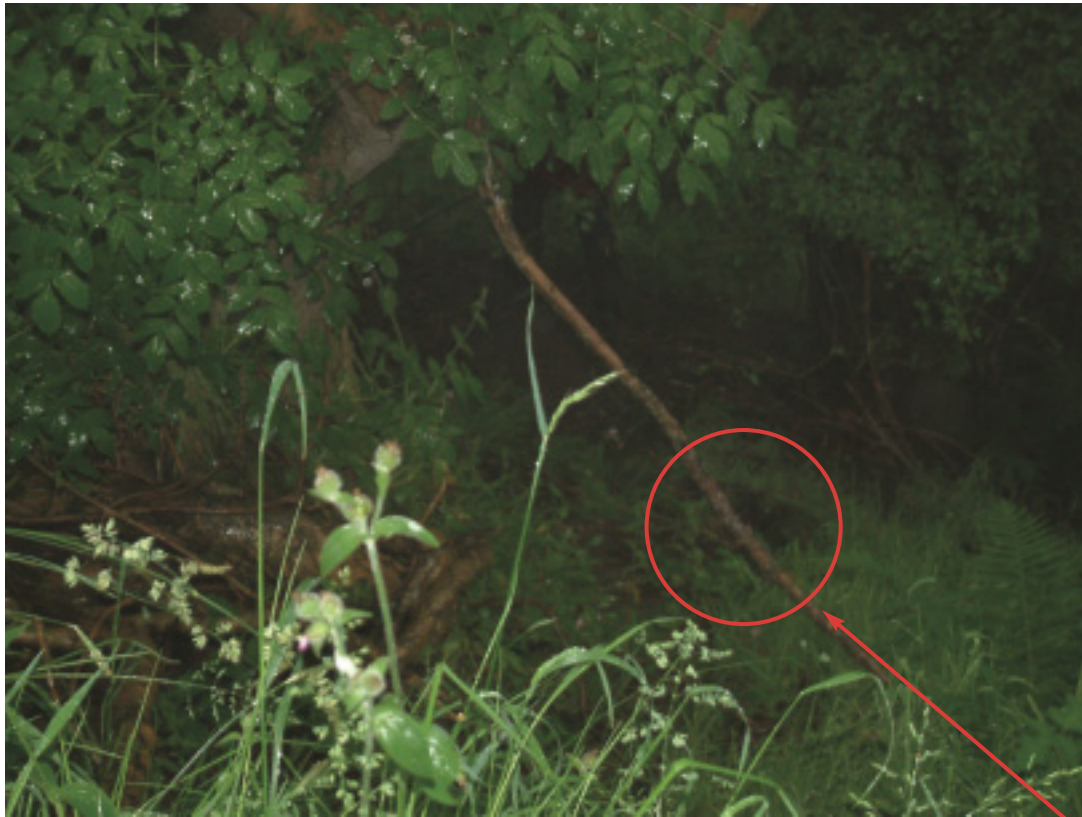
Question 40 was scored Yes – risk characterisation High – as the tank (B2 Figure 5.11), which was located in a wood, had inadequate protection around it. The hazard assessment likelihood score was scored as permanent (16) with an overall score of 128.

Figure 5.11 Tank B2 located in wooded area with inadequate protection

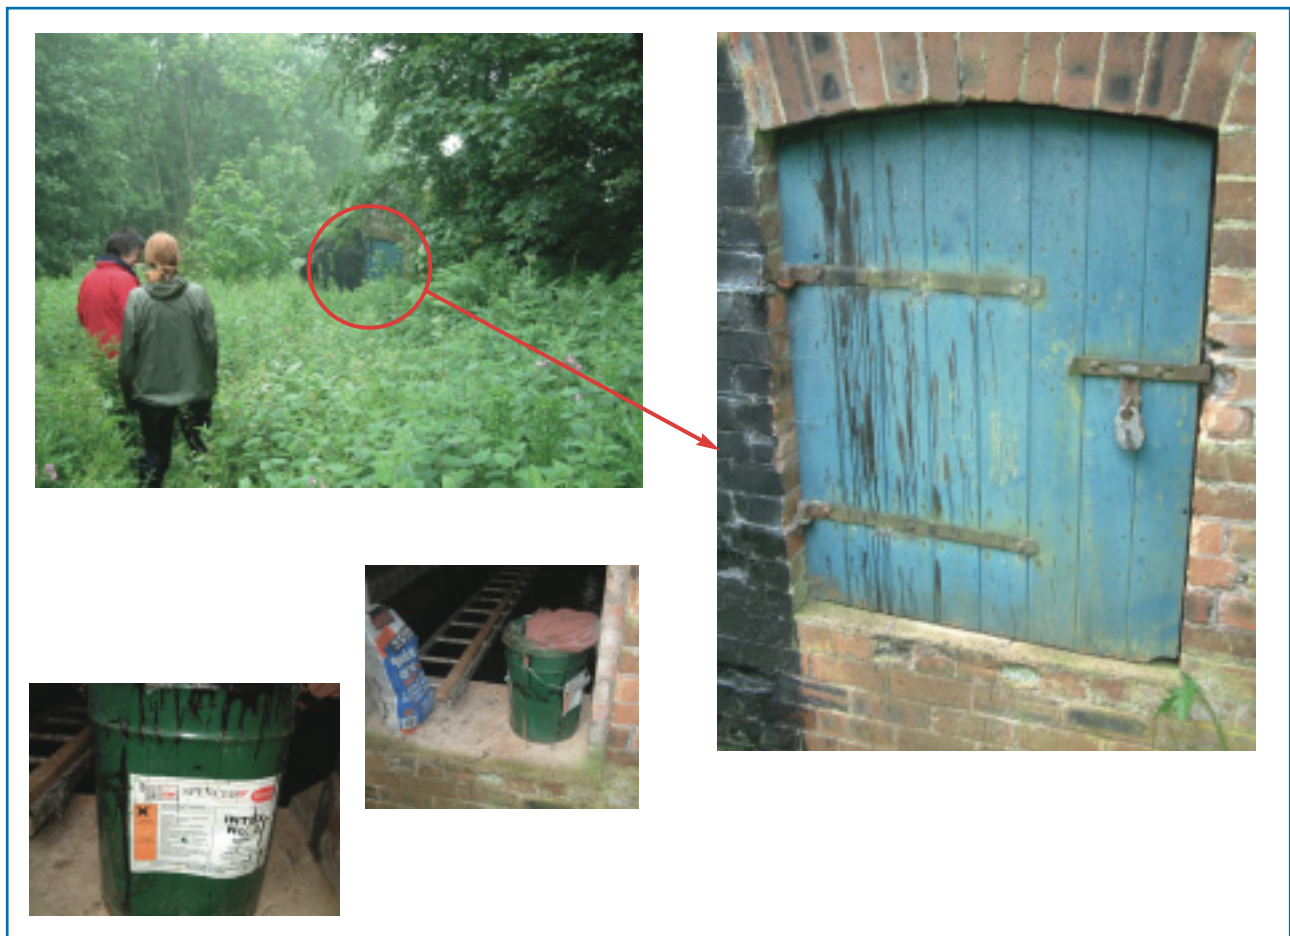
Question 41 was scored as Yes – risk characterisation High – as the tank was not secure against vermin and, despite having had substantial remedial works undertaken, was in a poor state of repair. There was also evidence that the inside of the tank had been coated with a bitumen paint which was totally inappropriate for such a use. The hazard assessment likelihood score was considered to be permanent (16) with an overall score of 128.

Figure 5.14 Tank B2 showing inappropriate bitumen paint used in internal tank repairs

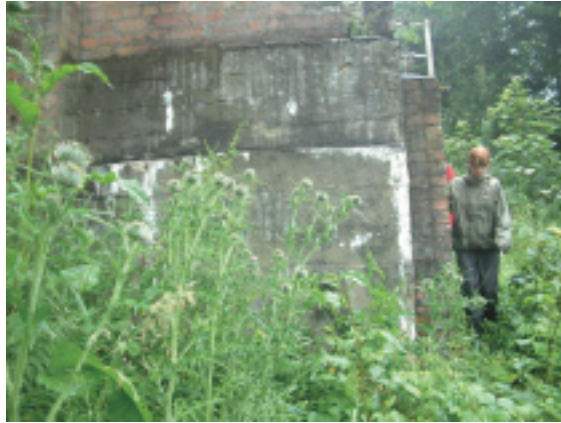
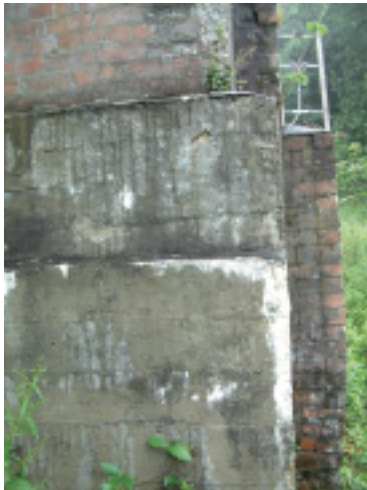
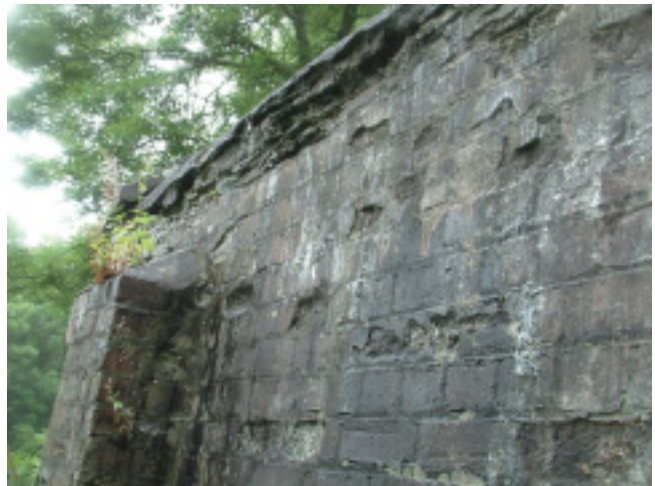
Figure 5.16 Tank B2 showing poor external condition and structural repairs

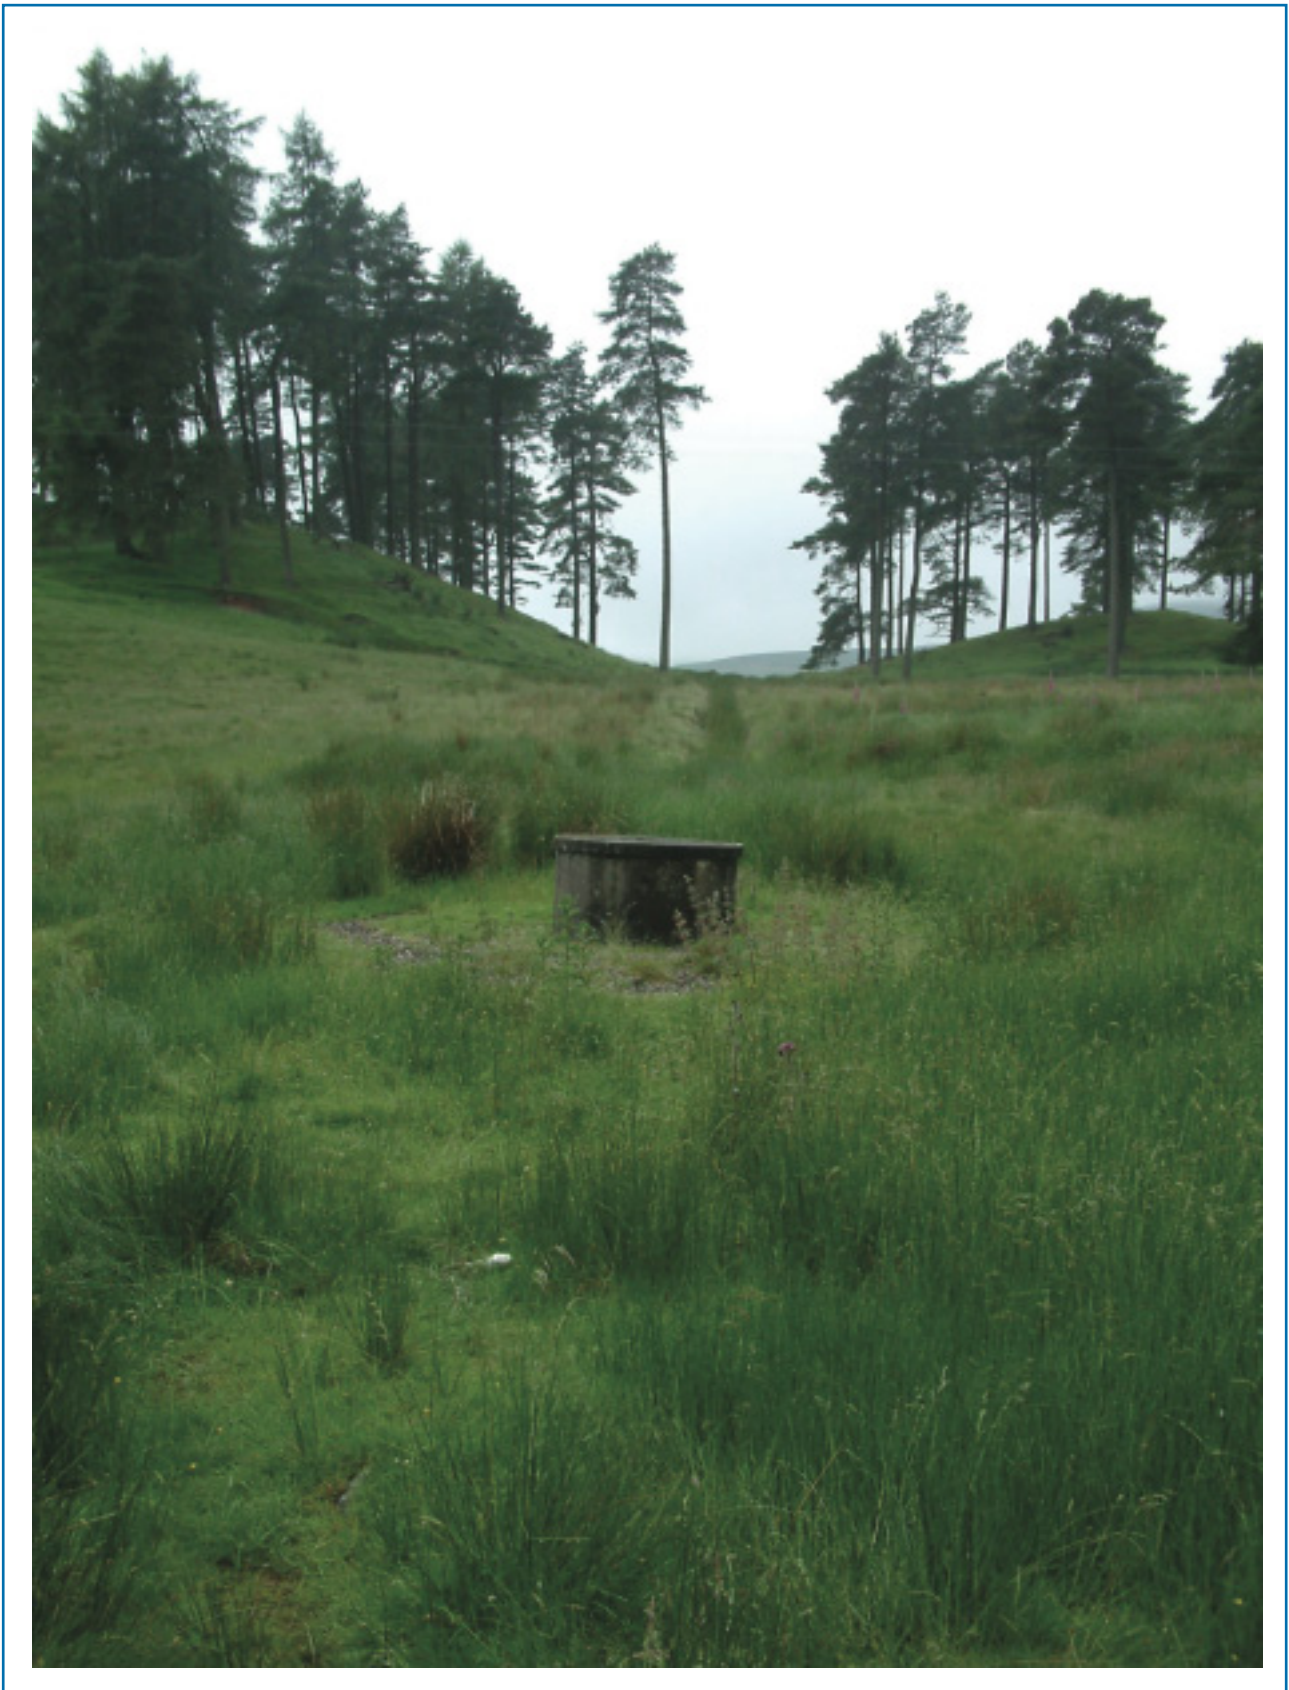
Question 23 – the risk characterisation was assessed as High as there was evidence of poor drainage and stagnant surface water. The well had been constructed by excavating a hole and inserting concrete rings to form the well structure. The area around the outside of these concrete rings had been backfilled with gravel which also formed the basis of drainage channels radiating out from the well. The area around the well away from the gravel backfill was extremely boggy as evidenced by standing pools of water and also the vegetation types in the vicinity. The hazard assessment considered these conditions to be permanent and so the likelihood score was 16 with the overall score as 128.

Figure 5.19 Well structure and boggy ground around source A1

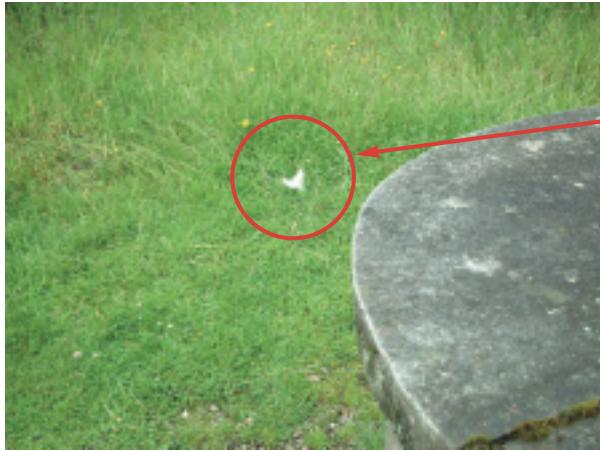
Figure 5.20

Evidence of sheep (cast wool) at well

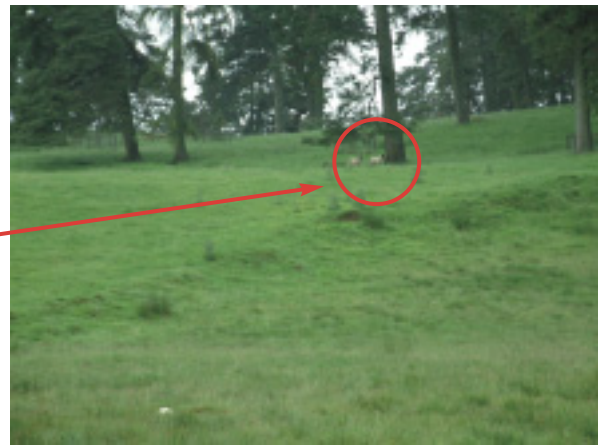
Question 24 – the risk characterisation was High and the hazard assessment likelihood score of 16 was based on permanent presence of livestock in the vicinity resulting in an overall score of 256.

Sheep near well (upslope)

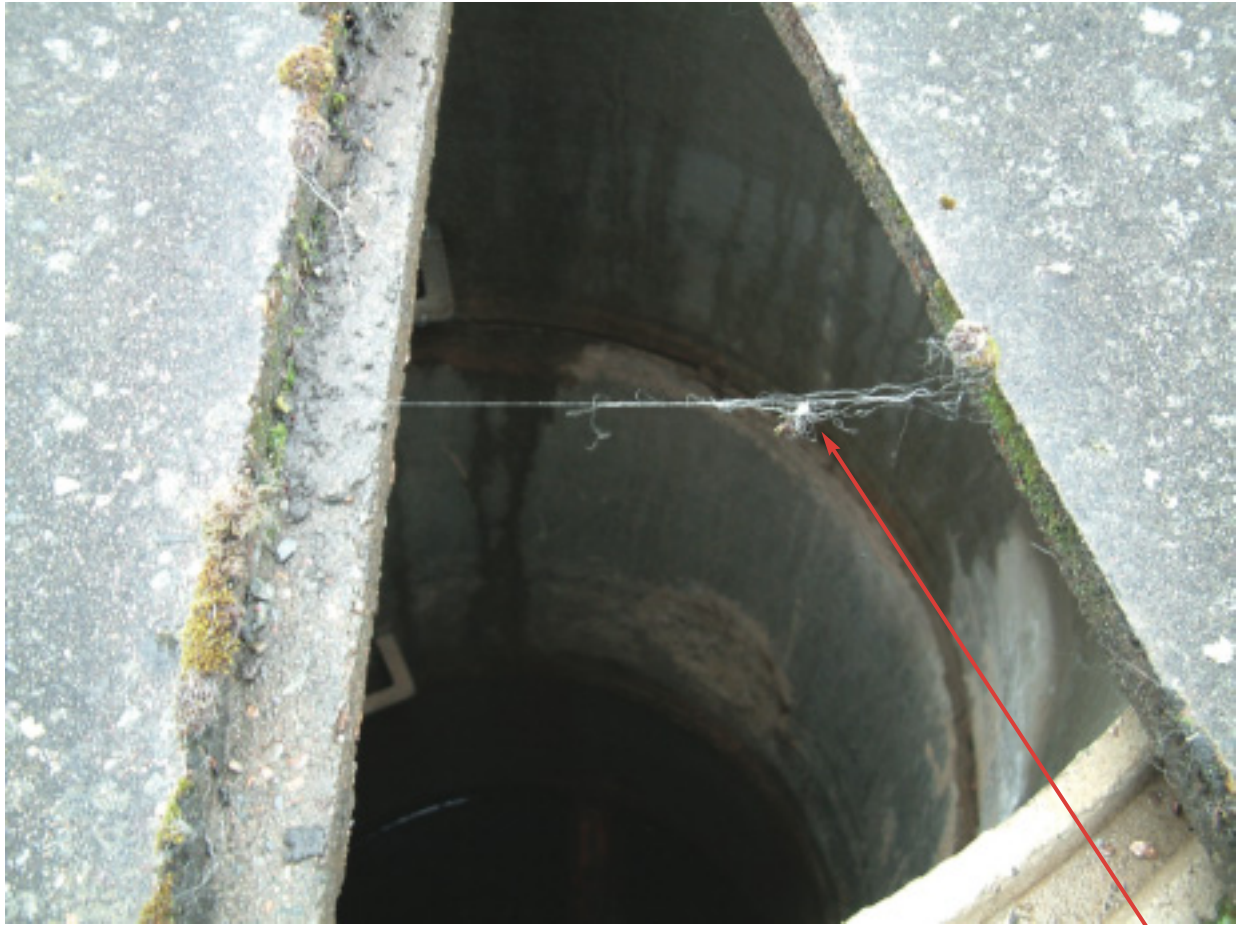
Figure 5.22

Evidence of presence of sheep on top of well cover – cast wool

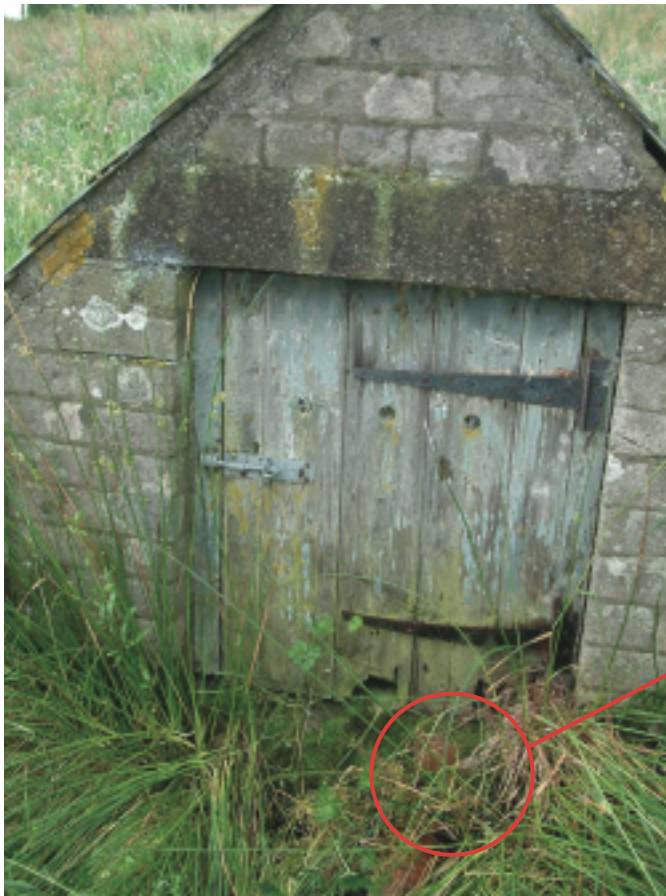
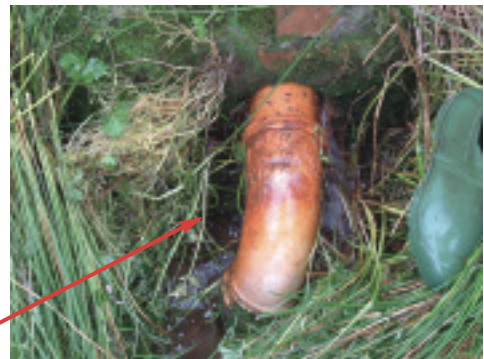
Figure 5.26

Overflow pipe at source A3

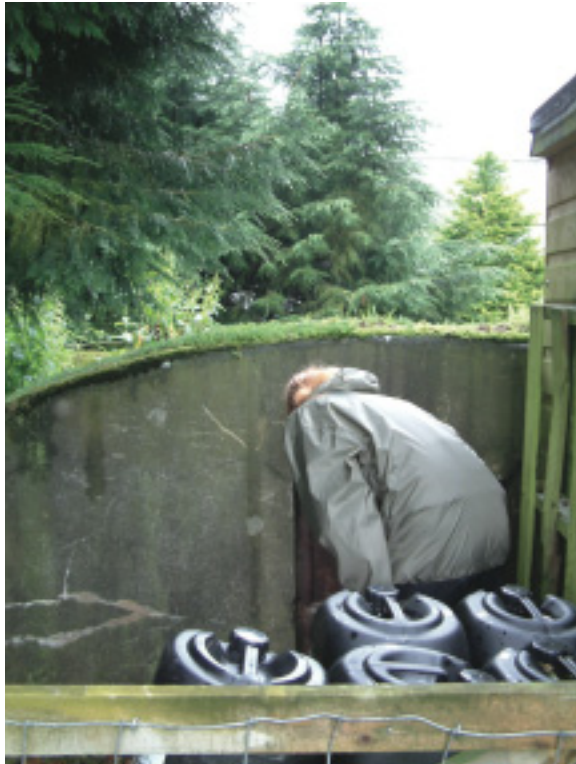
Question 41 – the intermediate tank B1 (at Drumhit) also functioned as a chlorination point for part of the system. The tank was not adequately protected from ingress of vermin or from flooding. The tank was located in an area beside a farm yard where cattle and sheep were moved and beside a field in which livestock were grazed. This resulted in the risk characterisation being scored as Yes – High – and the likelihood score as 16 with an overall hazard assessment score of 128.

Figure 5.27 Tank B1 Drumhit

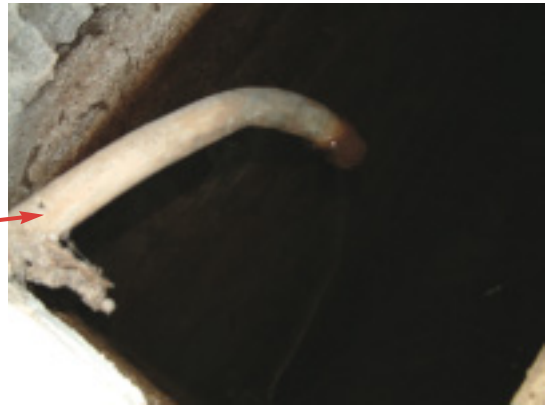
- (a) lead pipe – at source A3 (Evenedge) there was evidence that at least part of the system was plumbed using lead pipe. This should be brought to the attention of the relevant person and appropriate sampling undertaken to determine whether the lead levels exceed the Regulatory limits.

Lead pipe?
