The James  
**Hutton**  
**Institute**

**Effect of maintenance  
and different raw water  
quality parameters on  
ultraviolet (UV)  
disinfection in private  
water supplies in  
Scotland**

**CR/2012/01**

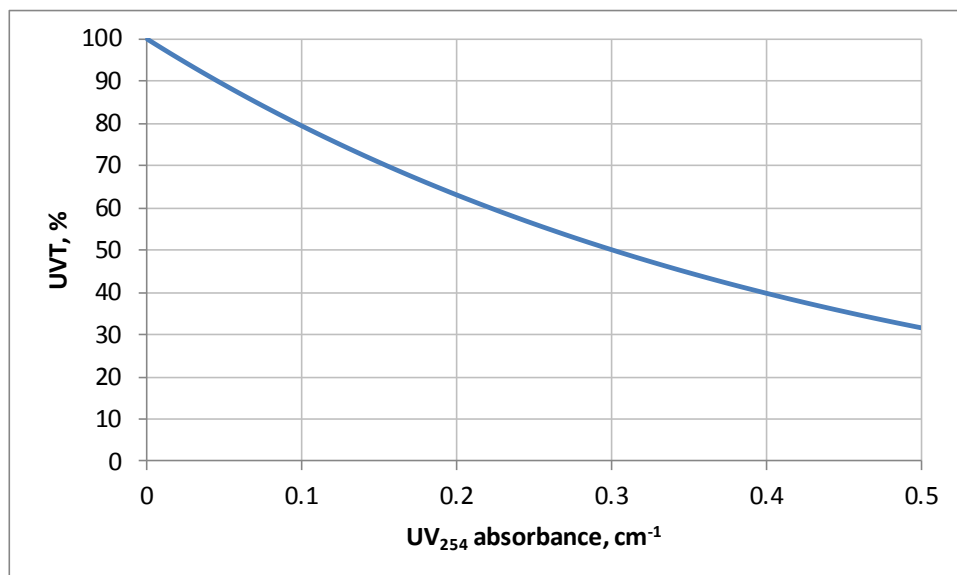
**Figure 2.1- Relationship between UVT and UV<sub>254</sub> absorbance**

Substances present in water that can decrease UVT include natural organics, phenolic compounds, some metals and anions such as iron and manganese. In coloured waters from peaty catchments the colour is a consequence of, and the measured value will correlate with, dissolved organic carbon (DOC) (e.g. Figure 2.2); and UV<sub>254</sub> absorbance is also an artefact of, and will correlate with, DOC (e.g. Figure 2.3, for two Scottish sources). So although there is no universal relationship between **colour** and UV<sub>254</sub> absorbance, these two determinands can be expected to correlate for a given water source, such that a higher value of either will correspond to a lower UVT.

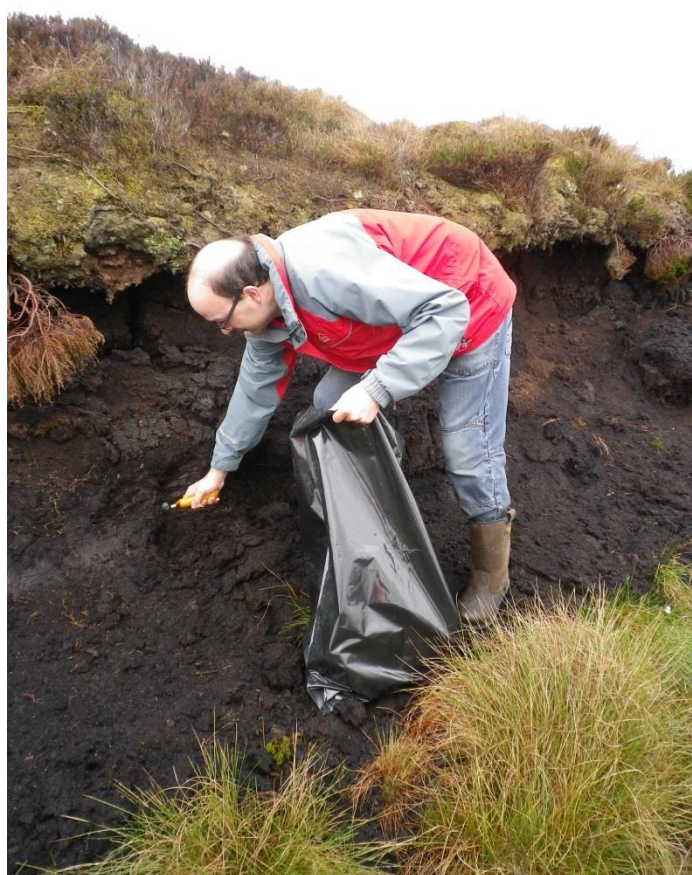
**Figure 4.1** Peat sampling at the Moss of Fishrie, Aberdeenshire (Grid Reference NJ835593)

available humic acid had an unacceptable ash content that caused an imbalance in the water recipes. Due to this, peat was collected from the Moss of Fishrie in North Aberdeenshire (Grid Reference NJ835593; Figure 4.1) as previous research into this area of hill peat by the James Hutton Institute had revealed that it has unusually low ash content.

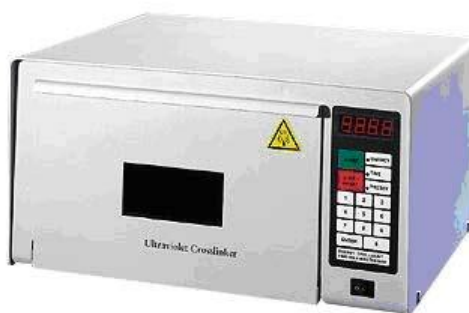
measuring the degradation of uridine exposed to UV light. As uridine degrades upon exposure to UV at a known rate, it is possible to relate reduction in uridine to UV intensity.

**Figure 4.2** UV Irradiation Box
