SECTION 5

RISK ASSESSMENT CASE STUDIES

These cases studies illustrate the **practicalities of carrying out risk assessments** on private water supplies. They focus on the **site survey** and **supply survey** questions, providing many useful photographs as well as the diagram required for each study.

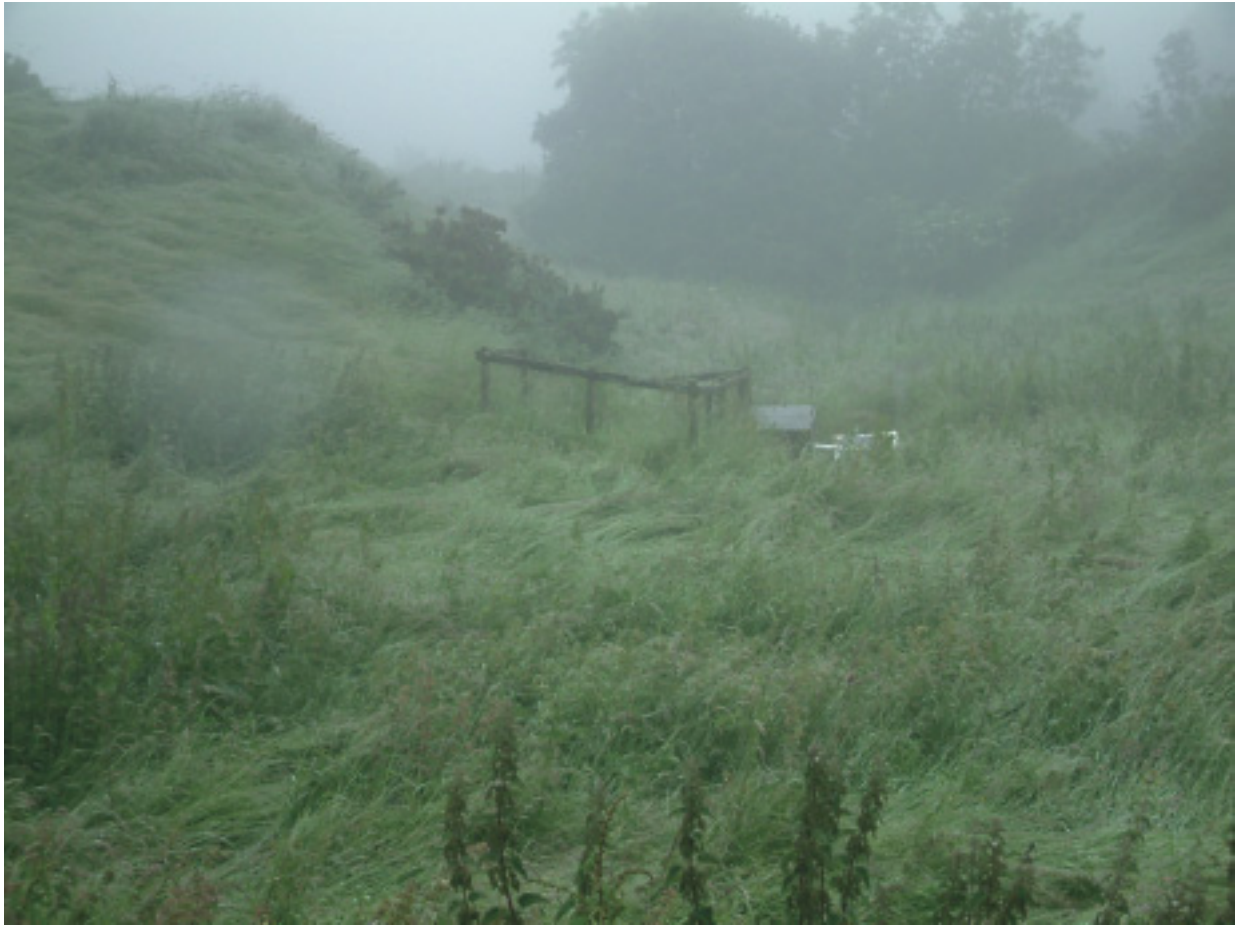
Question 23 was scored as Yes – risk characterisation High – as there was evidence of the surrounding catchment being used for livestock production on a year-round basis. The hazard assessment likelihood score was 16 giving an overall score of 256.

Question 24 was scored as Yes – risk characterisation Moderate – as there was evidence of wildlife in the area. As this was almost certainly a permanent feature the hazard assessment likelihood score was 16 giving an overall score of 64.

Question 25 was scored as Yes – risk characterisation High – as the source collection structure was down-slope of an area where agri-chemicals and other materials were being stored. The materials appeared to have been present for a long period of time and so the hazard assessment likelihood score was 16 giving an overall score of 128.

Figure 5.12 General catchment area immediately adjacent to source A1 (Weathertop)

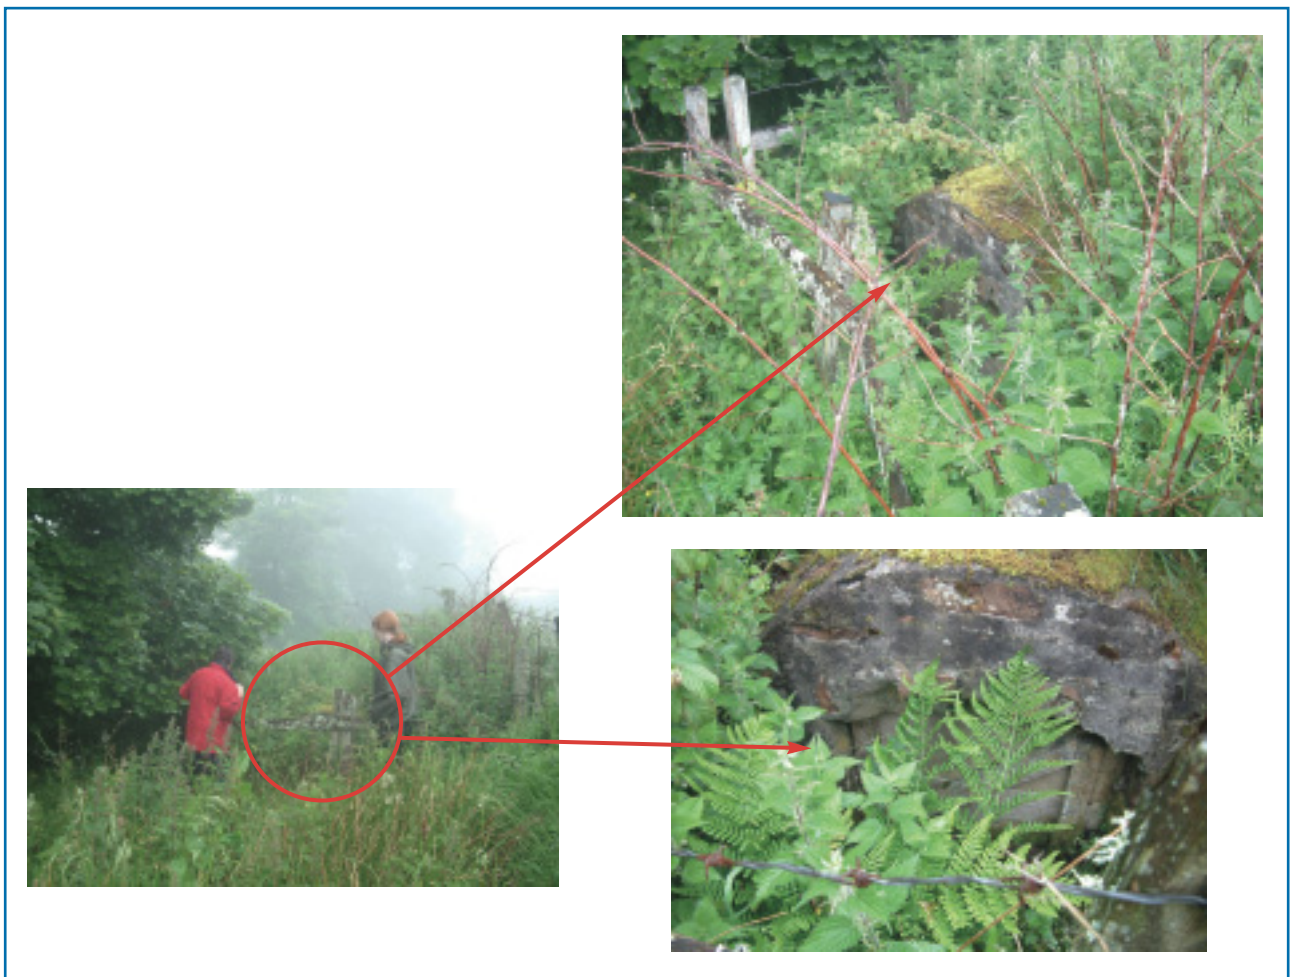
Figure 5.13 General Location of Source A3 Middlefield

Question 23 was scored as Yes – risk characterisation High – as the source was immediately adjacent to fields containing cattle and sheep. The fields were utilised for livestock production on a continuous basis and so the hazard assessment likelihood score was permanent (16) with an overall score of 256.

Question 24 was scored as Yes – risk characterisation Moderate – as there was evidence of wildlife activity in the vicinity of the abstraction point. The hazard assessment likelihood score was considered to be permanent (16) with an overall score of 64.

Question 25 was scored as Yes – risk characterisation High – as the abstraction point was down-slope from areas of livestock production. The hazard assessment likelihood score was considered to be permanent (16) with an overall score of 128.

Question 30 was scored as Yes – risk characterisation Moderate – as the abstraction point was adjacent to wooded areas populated with mostly broadleaf trees. The hazard assessment likelihood score was considered to be permanent (16) with an overall score of 64.

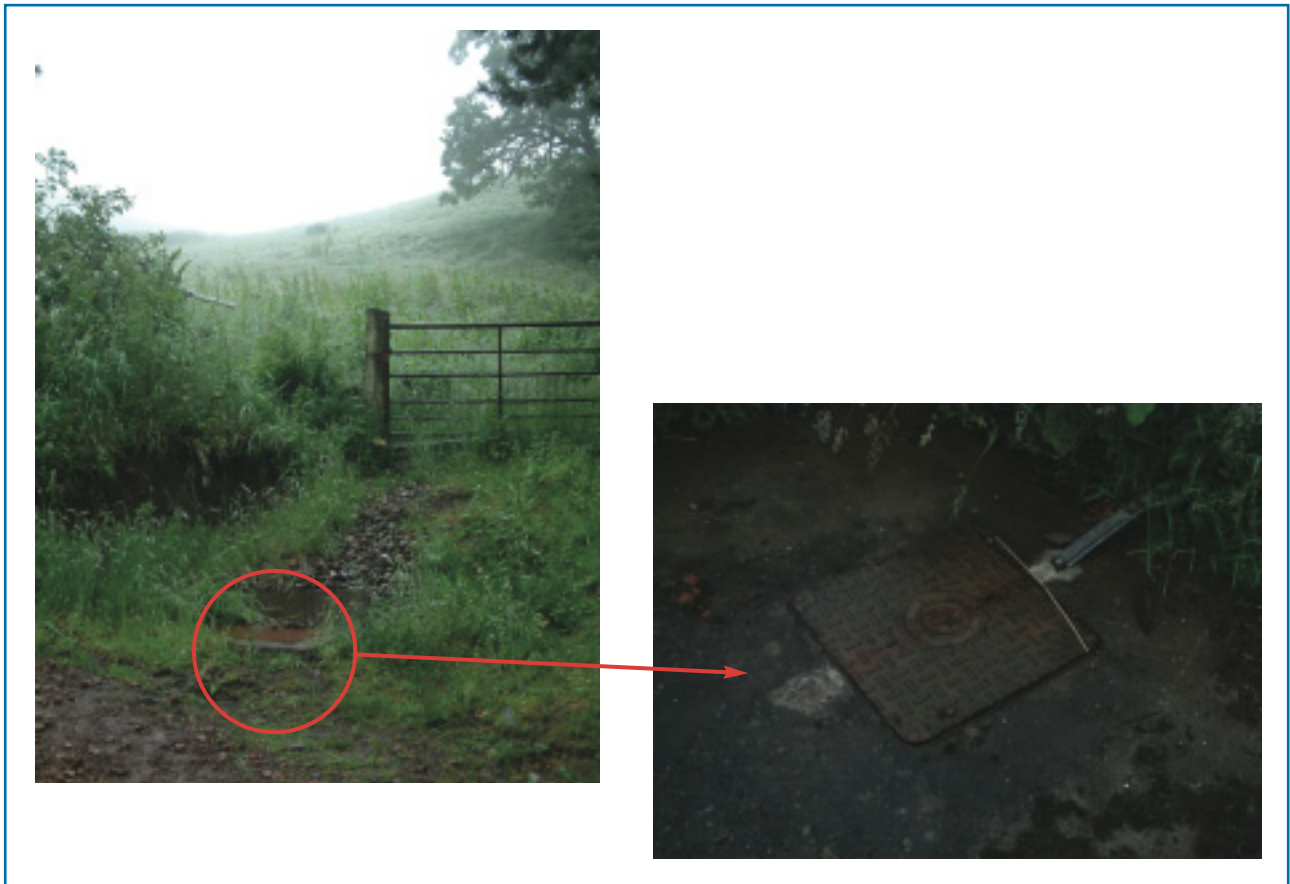
An additional note (See Figure 5.15) was also made concerning the state of the chamber where the lines from source A1 and A2 join. This was of poor construction with no effective protection against livestock, wildlife or inundation from rainfall/overland flow (flooding). The chamber was down-slope from an agricultural field with evidence of run off coming from the field near to the chamber. This additional evidence would also be considered to be a High Risk component of the system.

Figure 5.15 Chamber where pipework from sources A1 and A2 are considered to join

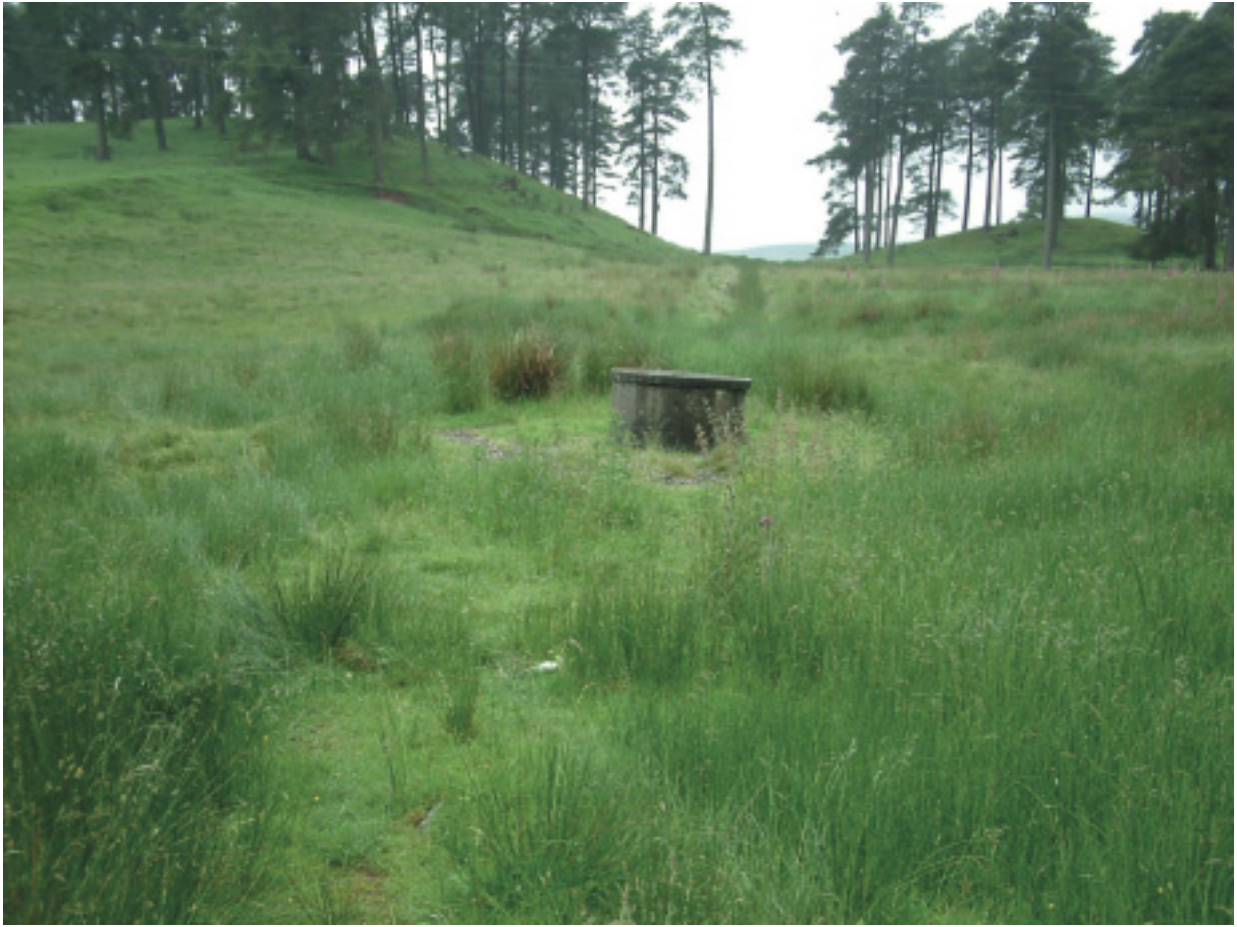
Figure 5.18 Site A1 Upper Lodge

Question 23 – the risk characterisation was assessed as High as there was evidence of poor drainage and stagnant surface water. The well had been constructed by excavating a hole and inserting concrete rings to form the well structure. The area around the outside of these concrete rings had been backfilled with gravel which also formed the basis of drainage channels radiating out from the well. The area around the well away from the gravel backfill was extremely boggy as evidenced by standing pools of water and also the vegetation types in the vicinity. The hazard assessment considered these conditions to be permanent and so the likelihood score was 16 with the overall score as 128.

Question 24 – the risk characterisation was High and the hazard assessment likelihood score of 16 was based on permanent presence of livestock in the vicinity resulting in an overall score of 256.

Question 25 – the risk characterisation was Medium and the hazard assessment likelihood score of 16 was based on permanent presence of wildlife in the vicinity resulting in an overall score of 64.

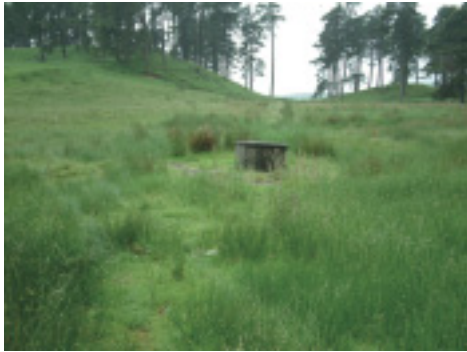
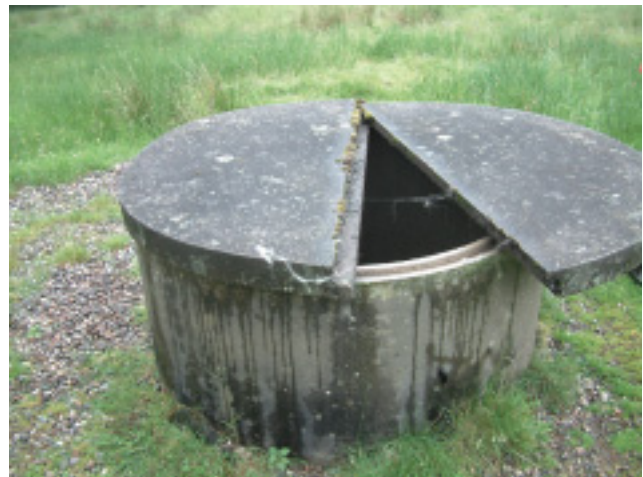
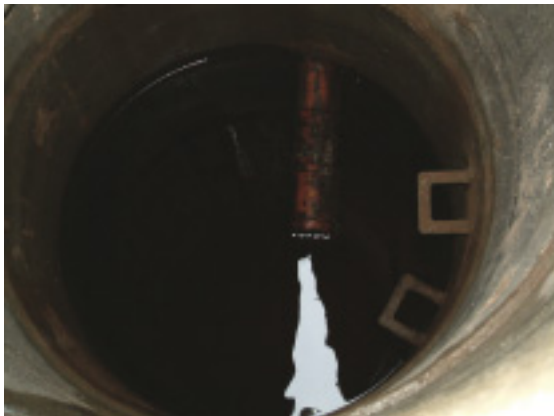
Figure 5.21

Question 42 – (lack of fence) - risk characterisation was High with the likelihood being assessed as permanent giving an overall hazard assessment score of 128.

Question 43 – (no cut-off ditch) - risk characterisation was High with the likelihood being assessed as permanent giving an overall hazard assessment score of 256.

Question 44 – (no concrete apron) - risk characterisation was High with the likelihood being assessed as permanent giving an overall hazard assessment score of 128.

Question 46 – (lack of appropriate cover) - risk characterisation was High with the likelihood being assessed as permanent giving an overall hazard assessment score of 256.

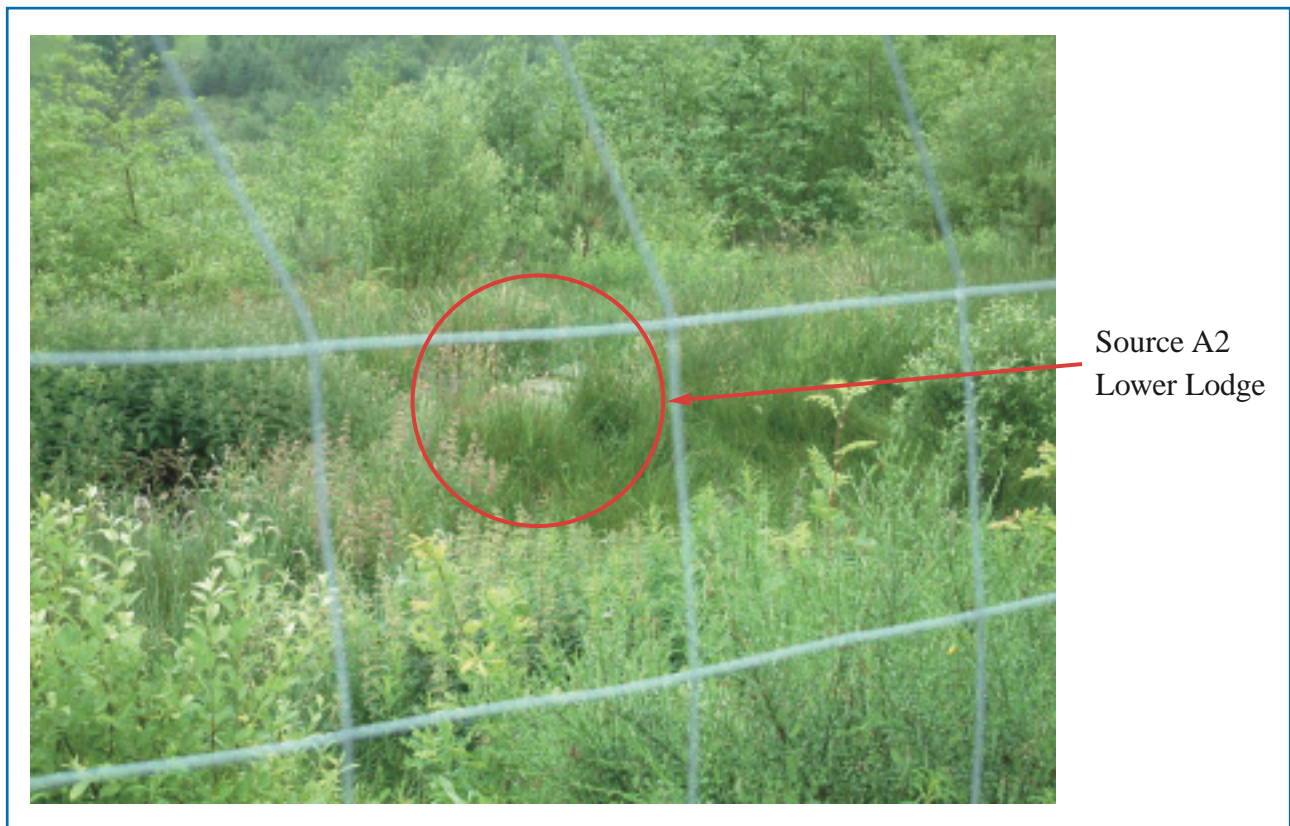
If we now consider the risk assessment for source A2 (Lower Lodge) the access to the site was severely restricted due to a deer fence and very steep slope. As access was not available at the time of the risk assessment the source was unclassified and so source A2 was designated as High Risk. A full risk assessment for the source A2 was not undertaken.

Figure 5.23 Source A2 Lower Lodge

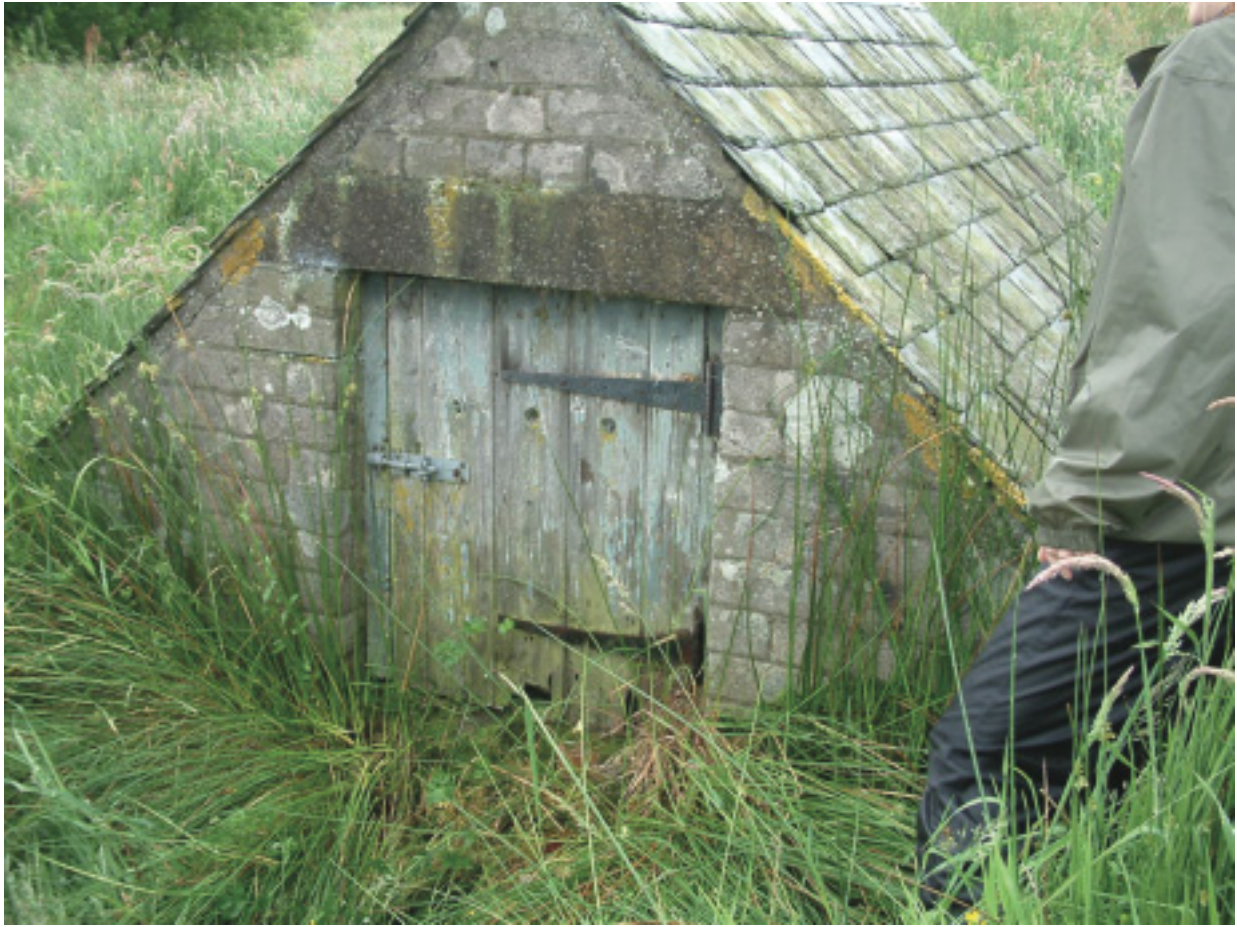
Source A3 (Evenedge) is located in an area of boggy ground. The source was historically identified as a spring source. While the boggy area may be being fed by water flowing from the ground the collection tank location and construction made it unlikely that the spring was being tapped at source i.e. within the rock formation. The boggy area may well be a seepage area with any water being collected from this area not being a spring water. When the water emerges from the rock formations into the seepage area the water will then be liable to contamination from the surface. For this reason the collection system as source A3 was scored as a surface water (Annex 5.5). Figure 5.24 gives more details on seepage areas and springs.

Figure 5.25 Source A3 Evenedge

Question 24 was scored as Yes – risk characterisation Moderate – as the presence of wildlife at the source was highly probable. The hazard assessment likelihood was almost certain (value 16) resulting in an overall score of 64.

Question 31 could not be accurately answered as the relevant person was not present during the risk assessment process. The risk characterisation was therefore High with the hazard assessment being scored on the assumption that agricultural workers did not know there was a supply in the area resulting in a likelihood score of 16 and an overall score of 64.

Question 34 was scored as Don't Know as there was a habitation above the abstraction site which may have had a septic tank. The Don't Know rating would suggest the need for further investigations into this matter. The hazard assessment was undertaken on the assumption that there was unsewered human sanitation in the vicinity on a permanent basis (value 16) giving an overall hazard assessment score of 256.

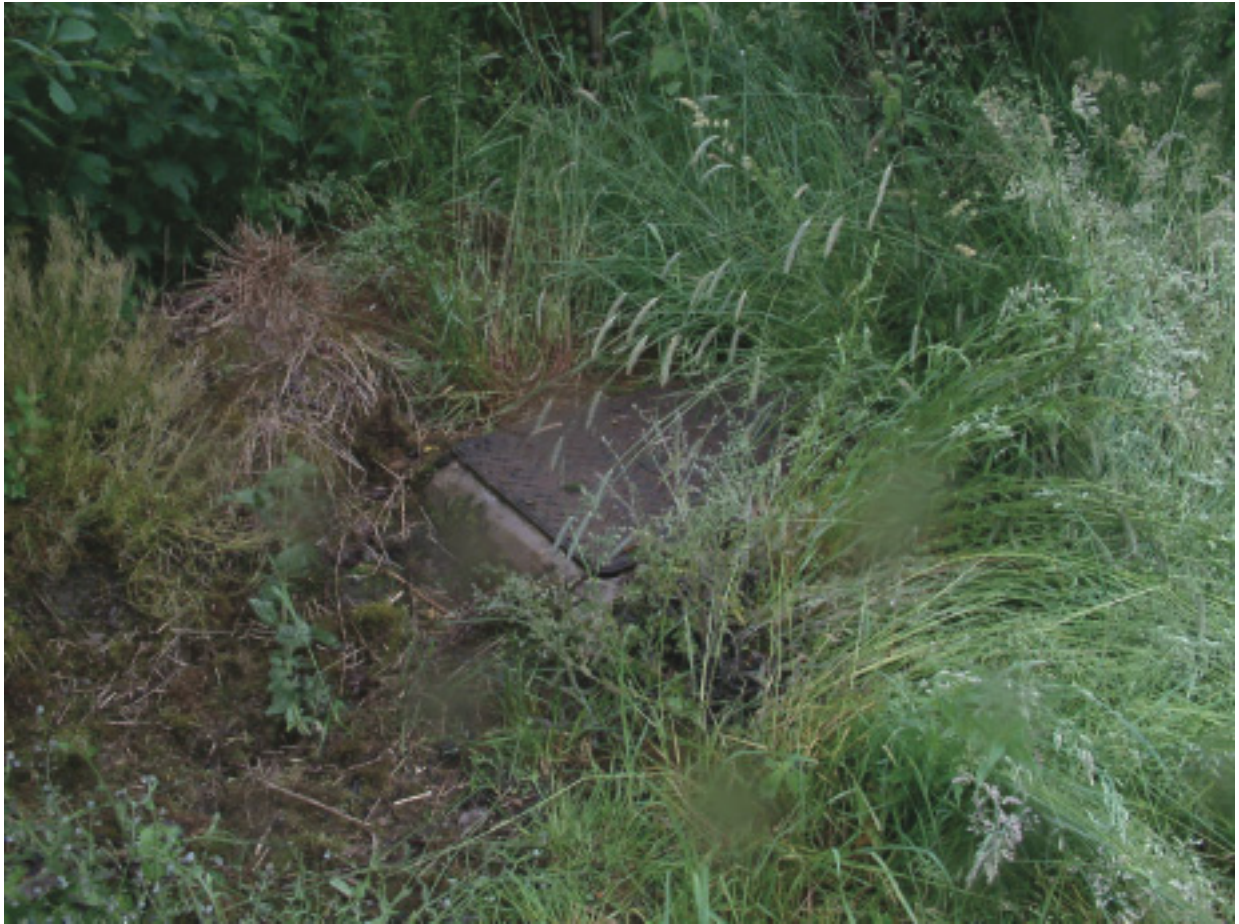
Question 40 – there was evidence of recent application of herbicide around and over the top of the borehole head works. This activity resulted in the risk characterisation being scored as Yes – High risk. The likelihood of such applications being repeated was judged to be likely (value 8) giving an overall hazard assessment score of 64.

Additional comments recorded were that the cover on the borehole chamber be fitted with a lock. The present arrangement, while difficult to effect removal of the cover, does not secure the cover adequately.

Figure 5.32 Waterbottom Borehole

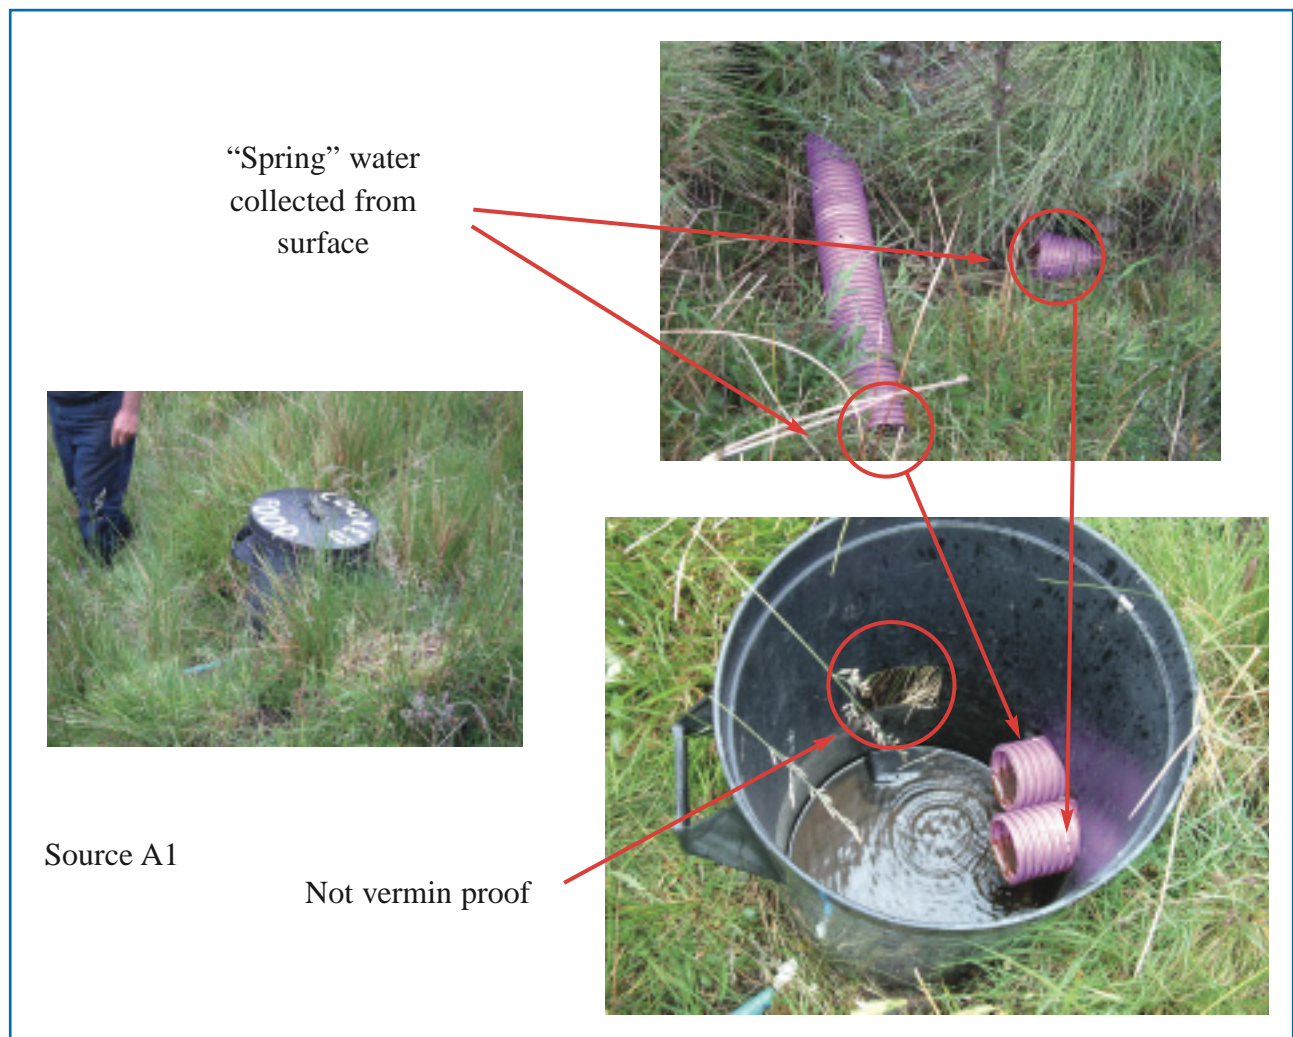
Figure 5.34 Source A1

The sources A1 – A6 were all of a similar nature – springs issuing from the hillside with a collection chamber either down-slope of the point where the spring emerged or within the soil horizon. None of the chambers were constructed so that they were within the rock matrix and therefore capturing the groundwater *in situ*. This meant that all the “springs” were capable of being under surface influence and so were scored as surface water. Further, given the common nature of the systems a single assessment was appropriate to cover the six separate collection areas.

Figures 5.34 – 5.38 provide evidence of the general condition of the sources and the intermediate collection tanks which also act as additional collection points. In general, while the groundwater risk assessment is appropriate, the additional comments section of the form would also be used to note that where there are structures present they are not water or vermin-proof and therefore allow additional points of entry for material best kept out of the drinking water supply.

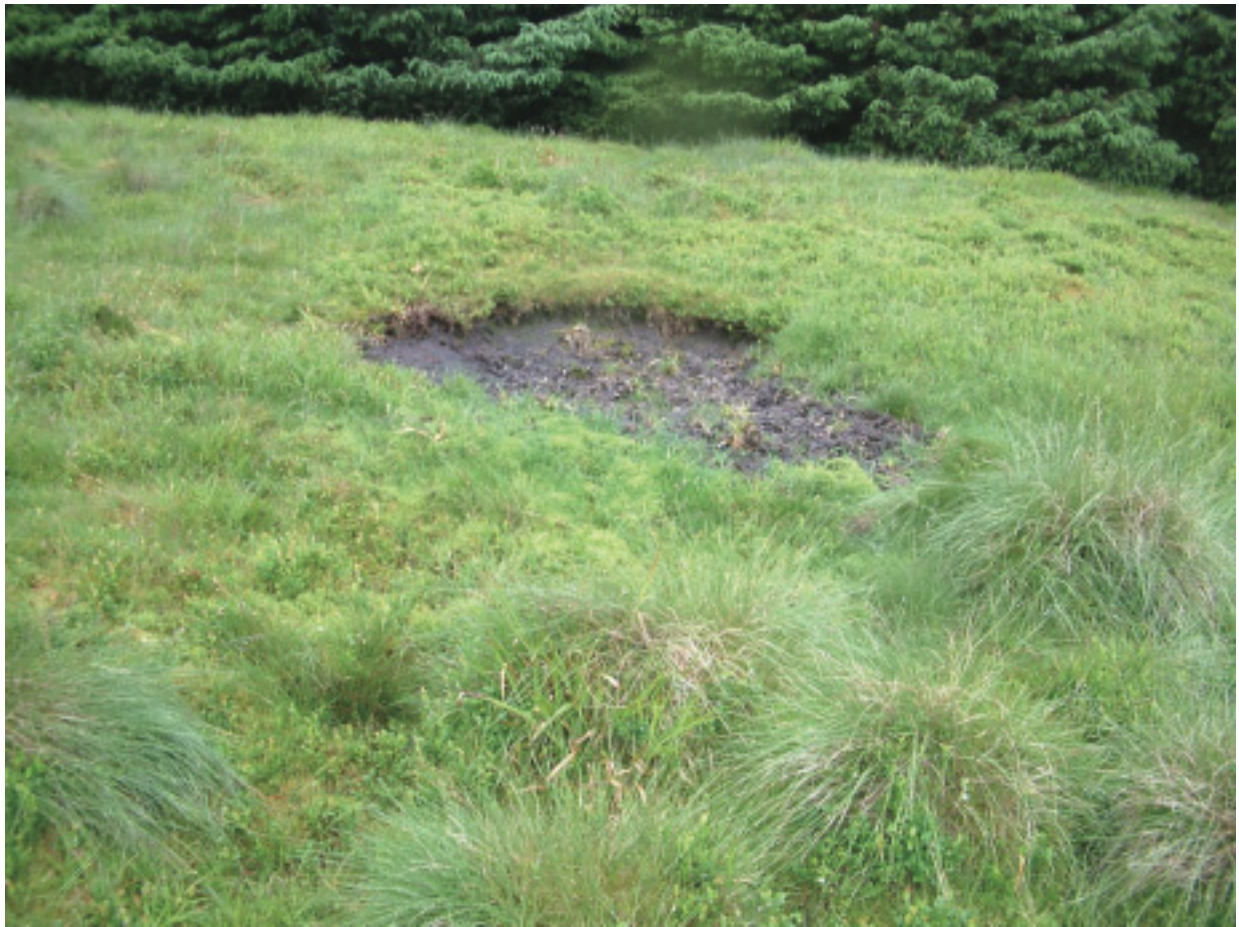
For the general site survey risk characterisation for Question 23 – history of livestock production - was scored as “Yes” (High Risk). While no livestock were found at the time of the investigation there was ample evidence of their presence in the area. The hazard assessment likelihood score was therefore likely (8) with an overall hazard assessment score of 128.

Figure 5.40 “Scrape” in catchment

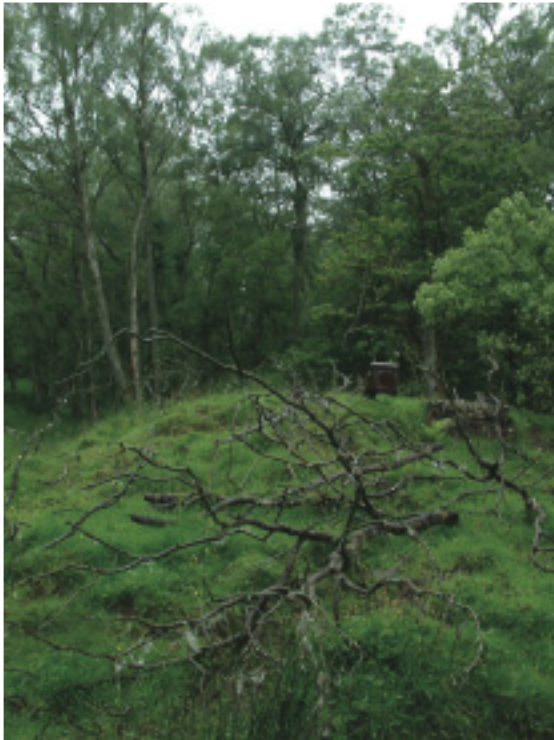
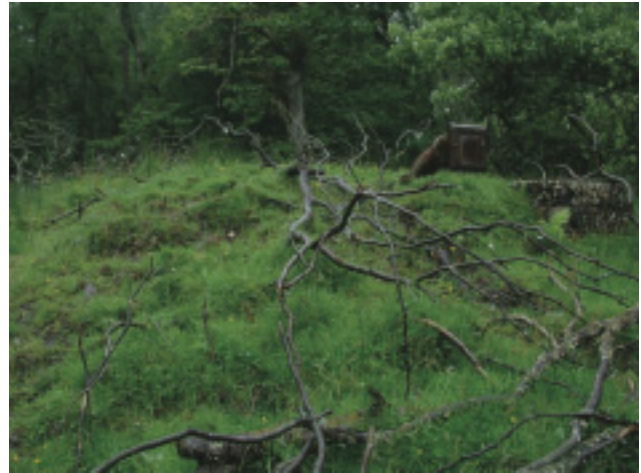
Figure 5.41 Intermediate Tank B1

Intermediate tank B1

The risk characterisation for Question 41 was High – intermediate tank B1 (Figure 39) was in a very poor state of repair and the local landowner actively used the top of the tank as winder grazing for sheep; intermediate tank B2 (Figure 40) was in a similar poor state of repair with sheep evidently using the tank for grazing as their wool had been caught on the ineffective fence surrounding the structure. Neither were vermin-proof nor were they capable of stopping the ingress of water through the structure. For these reasons the hazard assessment was almost certain (16) giving an overall hazard assessment score of 128.

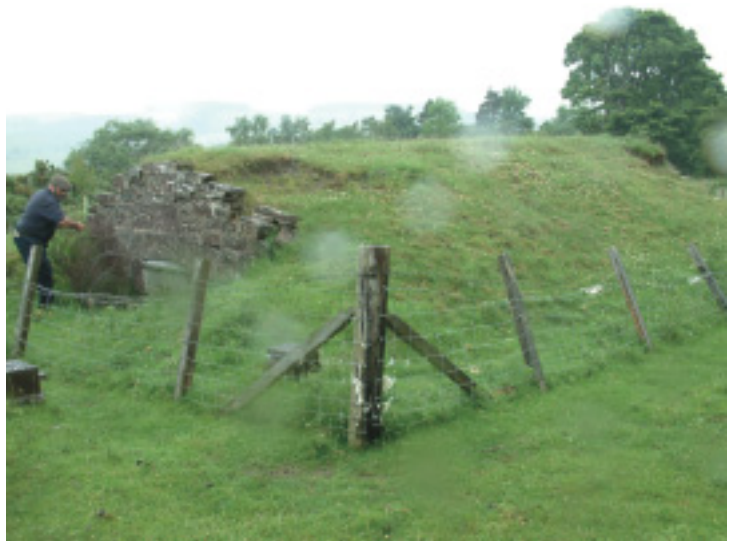
Intermediate tank B2

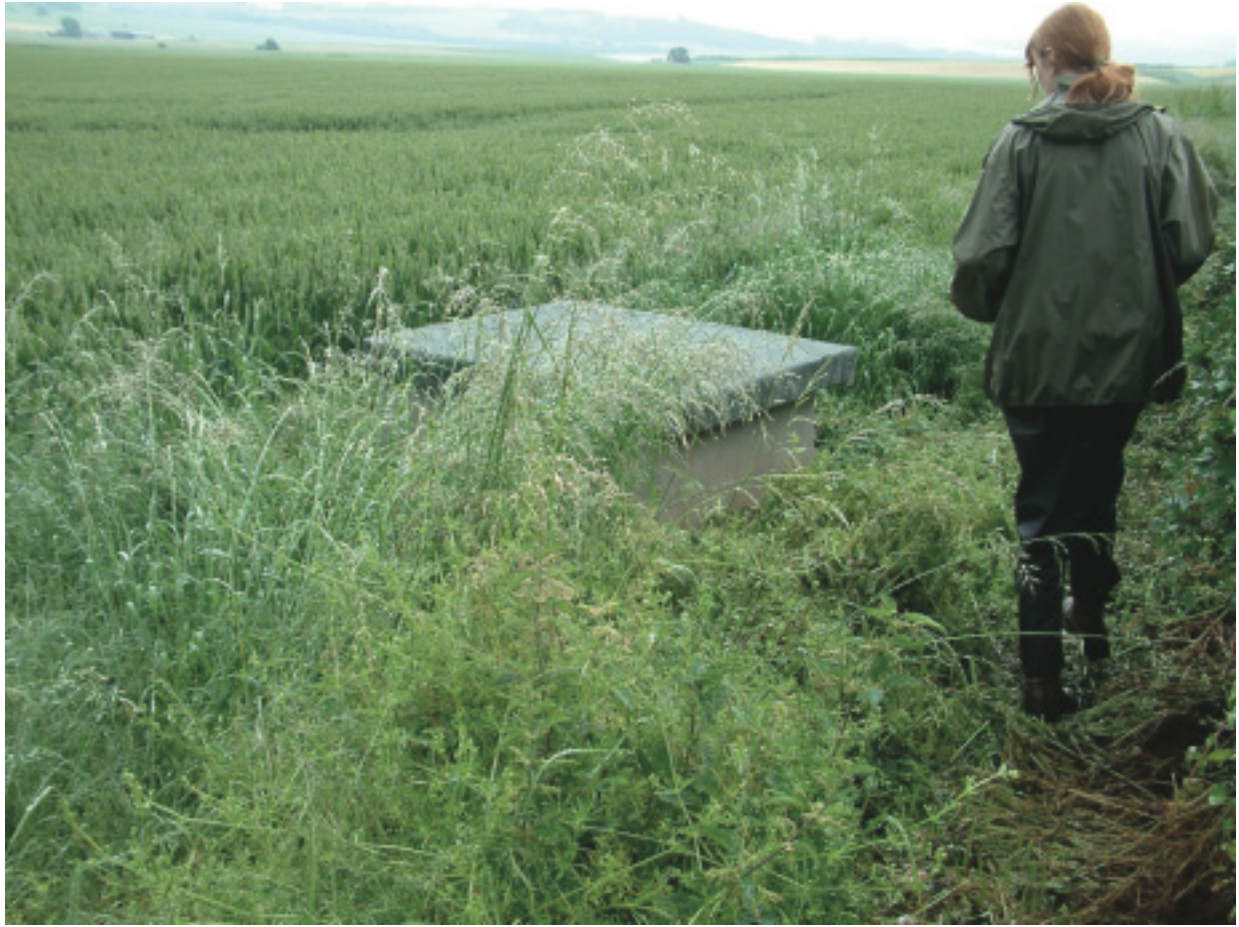
Figure 5.44

Due to the very close location of arable crops and no attempt to ensure an adequate separation from the borehole the risk that pesticides or other materials may be sprayed or applied to the field could enter the borehole is high and so the risk characterisation is High with the hazard assessment likelihood being moderately likely (4) with an overall score of 32.

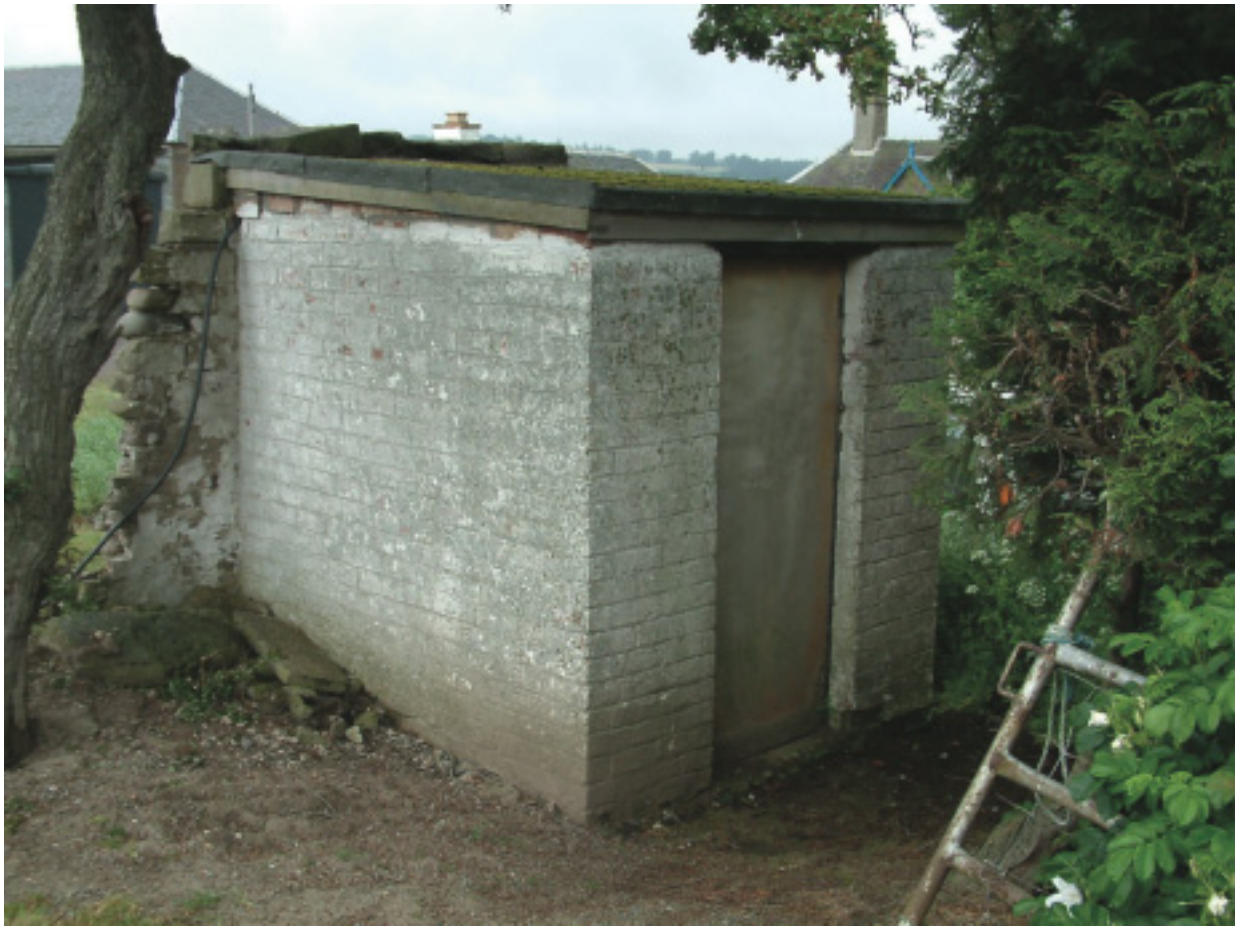
Figure 5.45

Discussion with the responsible person suggested that there had been no maintenance on the system in the previous 12 months. Question 52 was scored accordingly with the risk characterisation being scored as High; hazard assessment likelihood unlikely (2) with an overall hazard assessment score of 16.

B1 pump house and pressure vessel for Rooster supply
